# Duct Tape Durability Testing

**California Energy Commission**  
Public Interest Energy Research Program

**Lawrence Berkeley National  
Laboratory**

JANUARY 2005  
CEC-500-2005-008

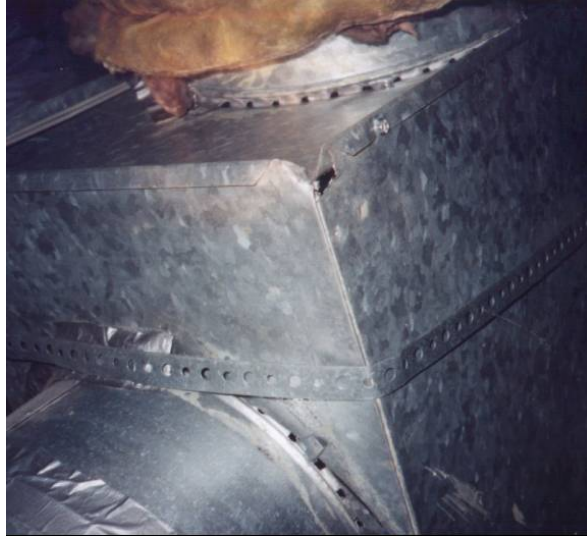
**Figure 1 Example Of Collar-To-Plenum Connections On A System Where The Tape Sealant Has Fallen Off**

Previous duct sealing tests conducted at LBNL covered two types of joints, core-to-collar, and collar-to-plenum, using sheet metal ducts and fittings. For the core-to-collar joints, the tape joined two concentric materials, thus exhibiting a 2-dimensional joint. However, the collar-to-plenum joints (Figure 1) are typical when a metal collar attaches to a duct branch, splitter box, or a supply or return plenum (see Figure 2). The collar-to-plenum joint was the most difficult to seal with duct tape because the leaks to be covered are not in a flat plane and the tape must be folded in order to conform to the joint. The round collar is mated through a circular hole to a flat piece of metal, with a set of flexible tabs that mechanically hold the collar in place with the use of sheet metal screws. The gaps between the tabs leave gaps of 1/8" to 1/4" (3 to 6 mm).

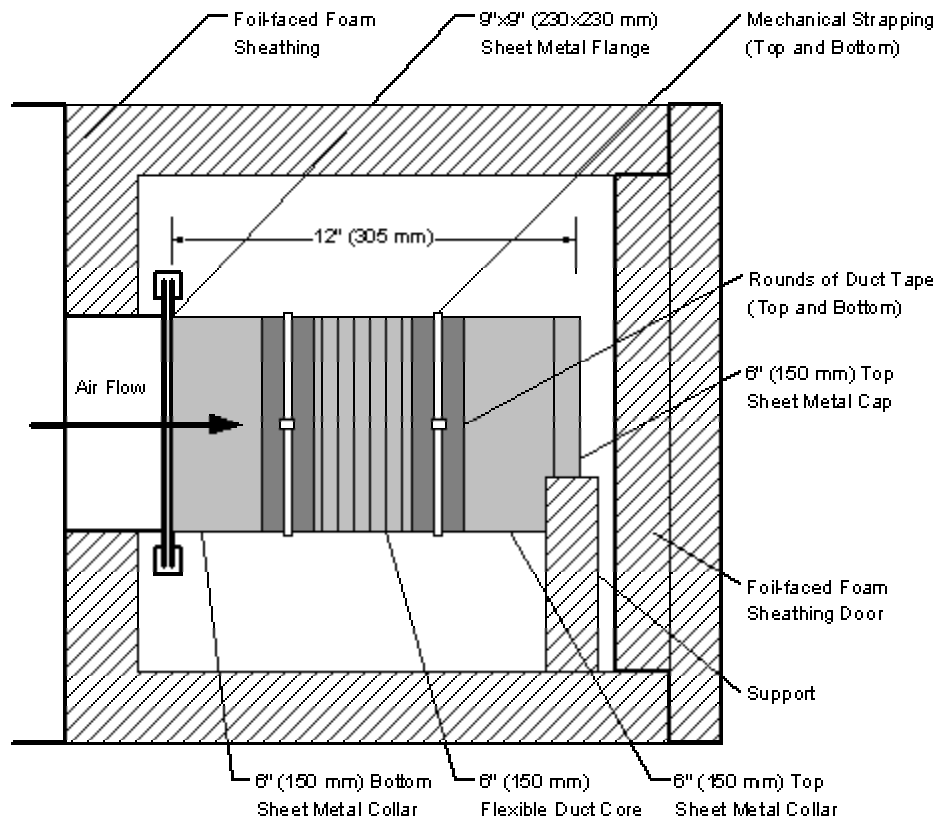
**Figure 4 A Side-View Schematic Of A Flexible Duct Core To Sheet Metal Collar Joint Specimen Positioned On The Aging Test Apparatus**

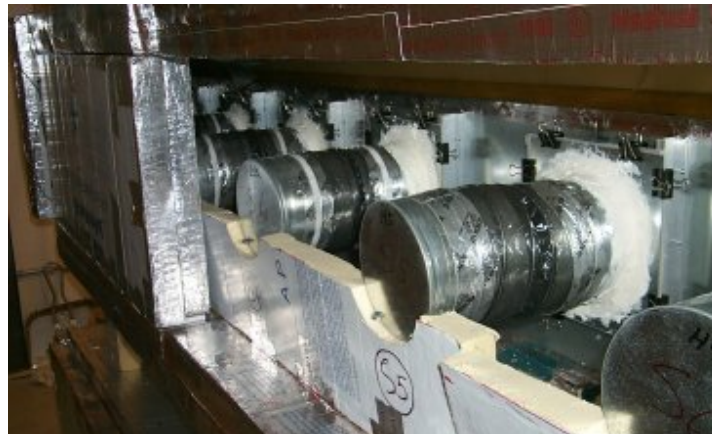
**Figure 5 One Chamber Of The High Temperature Aging Test Apparatus**

Figure 5 shows samples mounted on the aging test apparatus. Heated air is continuously circulated through the test apparatus to both heat and pressurize the leakage sites. The apparatus is divided into an upper and lower chamber that each contains nine samples. The inside of the test samples are exposed to high pressure (0.34 inch water (84 Pa)) heated air and the outside is in an insulated chamber that also becomes heated during the experiments by conduction through the test samples. This means that there is little temperature gradient across the samples. The hot air temperature (200°F (93°C)) is controlled using electric resistance heaters mounted directly in the air stream. The surface temperatures of each sample, the air temperature and the pressure across the leaks are continuously monitored using a computer based data acquisition system.

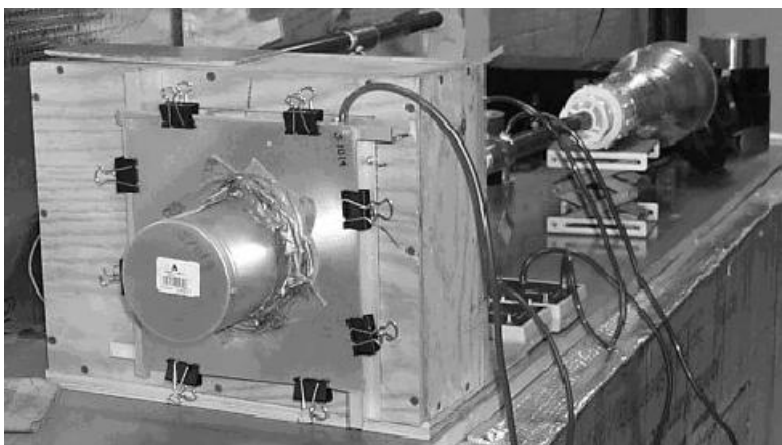
**Figure 6 Leakage Test Device For Pressurizing Test Samples. Test Sample Is A Collar-To-Plenum Joint**

The air leakage measurements were conducted periodically (typically on a monthly or weekly basis) by removing the samples from the test apparatus. They were then placed in a separate leakage testing device (Figure 6) that pressurized the samples to 0.1 in. water (25 Pa) and measured the airflow rate required to maintain the pressure difference. 0.1 in. water (25 Pa) was chosen because this pressure difference is used as a reference pressure in field testing of duct system leakage<sup>4</sup> and it is typical of average pressures across residential duct leaks.

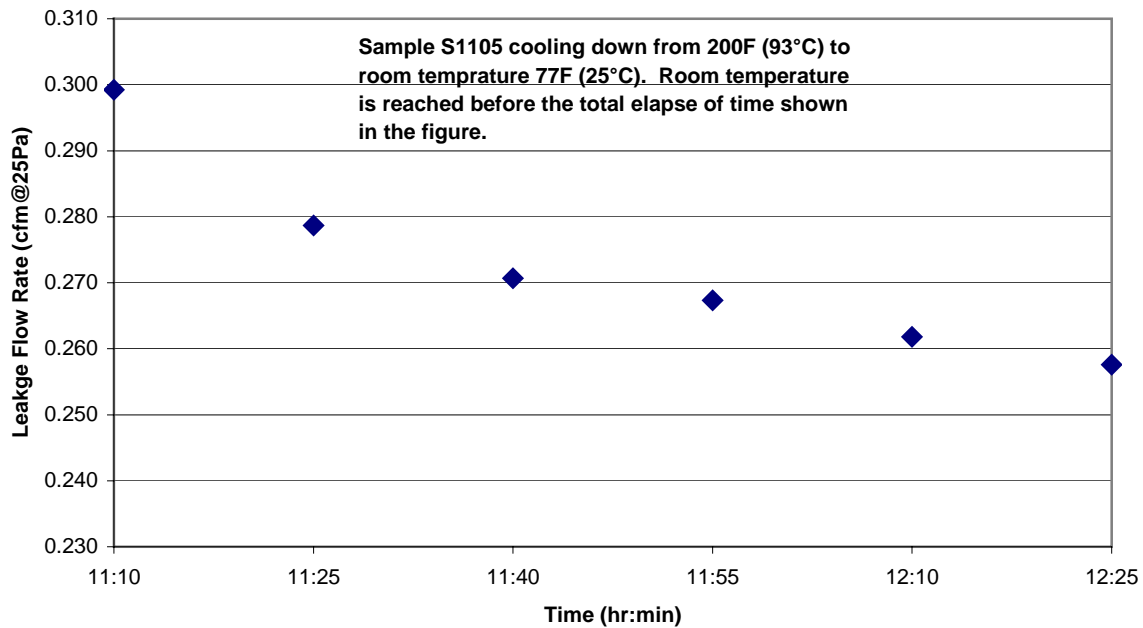
**Figure 7 Decay In The Measured Leakage As The Specimen Cools Down From 200F (93°C) To Room Temperature**

Because the aging test involves heating the specimens continuously at 200°F (93°C), it takes some time for the specimens to return to room temperature. Therefore the elapsed time between removal from the test chamber and measurement of leakage could have an effect on the results. To examine this effect, a specimen was tested six times at 15-minute intervals, with the first measurement taken at its highest temperature (200°F (93°C)). The experiment took place in the laboratory where room temperature is 77°F (25°C). Figure 7 shows the decay in the leakage flow the sample cools. The leakage flow at the highest temperature is 16% higher than the last value taken 1 hour and 15 minutes later. The difference in leakage is attributed to the “re-sealing” of the joint as it shrinks and hardens at lower temperatures. For consistent results the samples need to cool to room temperature before being leakage tested. Because this effect was not discovered until several months of tested had elapsed, some of these earlier results have additional uncertainty in measured sample leakage.

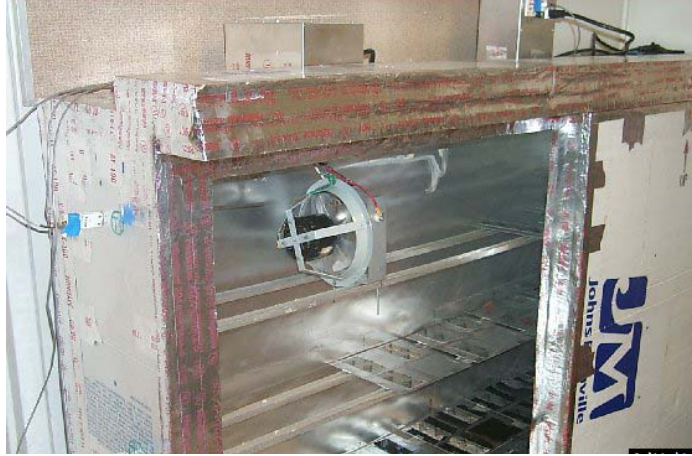
**Figure 8 High Temperature Baking Apparatus**

Figure 8 shows the baking test oven that provides constant circulating air temperature of 212°F (100°C) for the baking specimens following the UL 181B-FX “temperature test” protocol. All walls of the oven were made with 4” (100 mm) thick foil-faced foam sheathing. The bottom of the oven, sitting on the floor, was made thicker (6” (150 mm)) for added insulation. The oven was 44” (112 cm) high, 72” (183 cm) wide, and 10” (25 cm) deep. It contained four racks made of two strips of aluminum that hold the testing specimens. Six temperature sensors provided readings of the temperature profile inside the oven. Measured results show that the temperatures did not vary by more than 5°F (2.5°C) from the average temperature of 212°F (100°C). The oven had an electric heating unit controlled by a relay box to turn off at 214°F (101°C) and on at 210°F (99°C), and also protected by a safety snap thermostat rated at 250°F (121°C). The temperature values were recorded at a one-minute intervals.

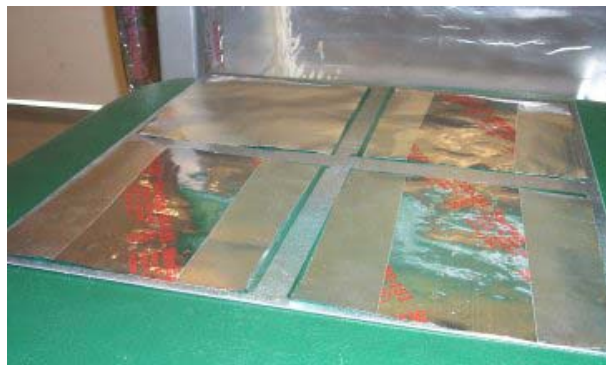
**Figure 9 Before Testing**

For each duct tape (Tape 1, Tape 2, Tape 3, and Tape 4), twelve specimens were made by applying a strip of tape to three 4 by 4 inch (100 by 100 mm) samples of each of the following materials: aluminum foil, polyethylene, polyethylene terephthalate (PET), and sheet metal (galvanized steel). Another 4 by 4 inch (100 by 100 mm) control sample of each of the substrate materials is also tested without applying the tape to it. The control sample serves as a means to quantify the deterioration attributed to the substrate in isolation from the duct tape. A specimen set in the baking test, therefore consists of three similar samples and one control sample, all carried by a sheet metal tray in the oven. Figure 9 and Figure 10 demonstrates A baking specimen following the UL 181B temperature test protocol consisting of three samples of tape (Tape 3) and one control sample of the substrate (Aluminum Foil) before testing (Figure 9) and after four weeks of testing (Figure 10).

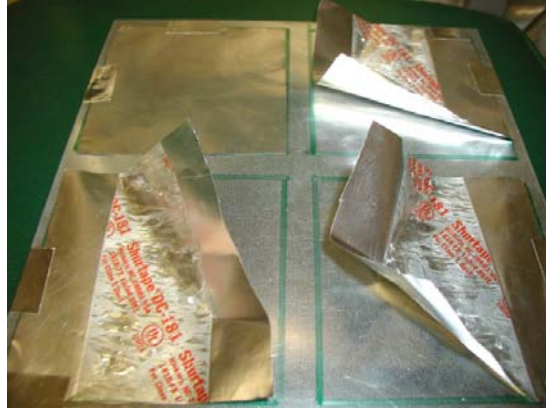
**Figure 10 After Four Weeks Of Testing**

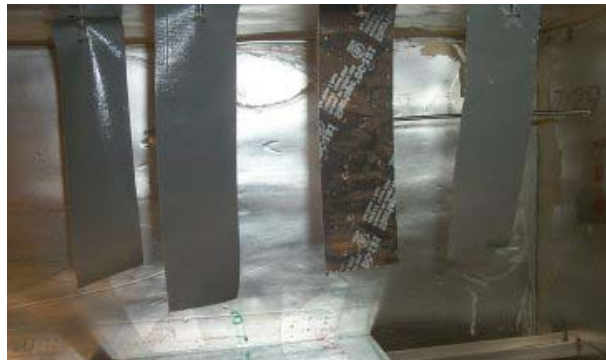
**Figure 11 Before Testing**

In addition, we included “hanging specimens” (Figure 11 and Figure 12) of all four tapes in the oven to examine their deterioration in isolation from the substrate. Hanging specimens of Tapes 1 to 4 in the high temperature baking apparatus before testing (Figure 11) and after three weeks of testing (Figure 12).

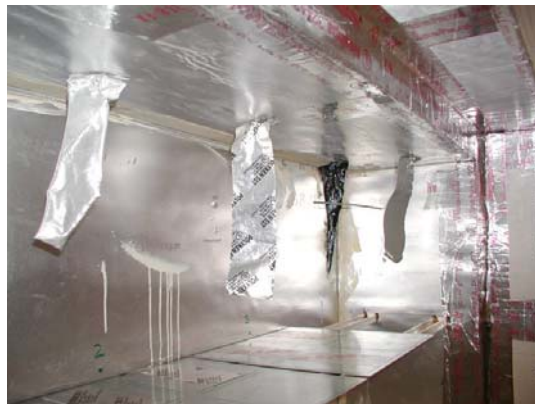
**Figure 12 After Three Weeks Of Testing**

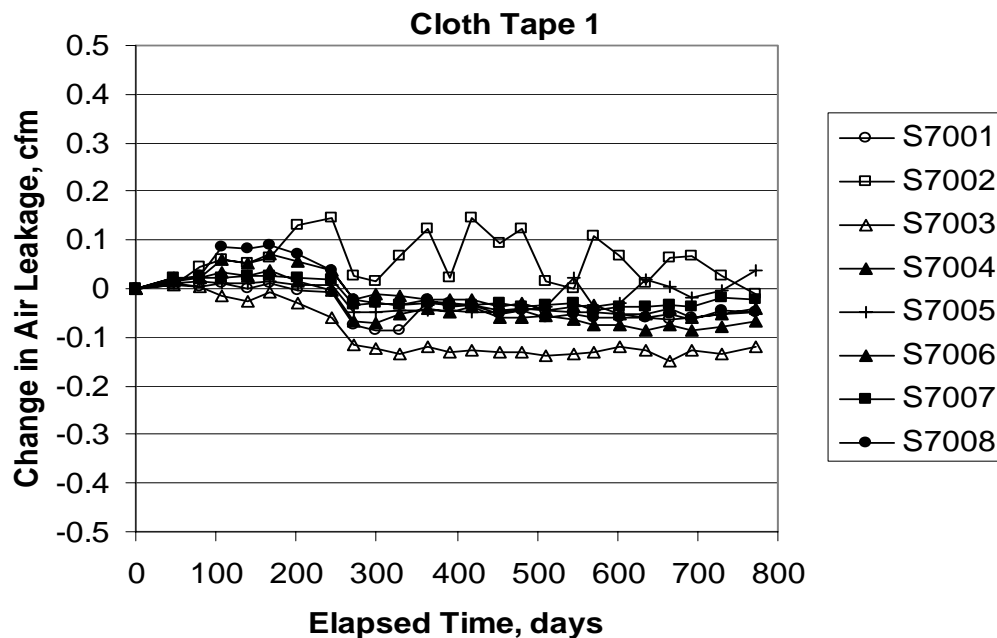
Figure 13 Two Year Testing Of Core-To-Collar Joint Specimens With Cloth Tape 1

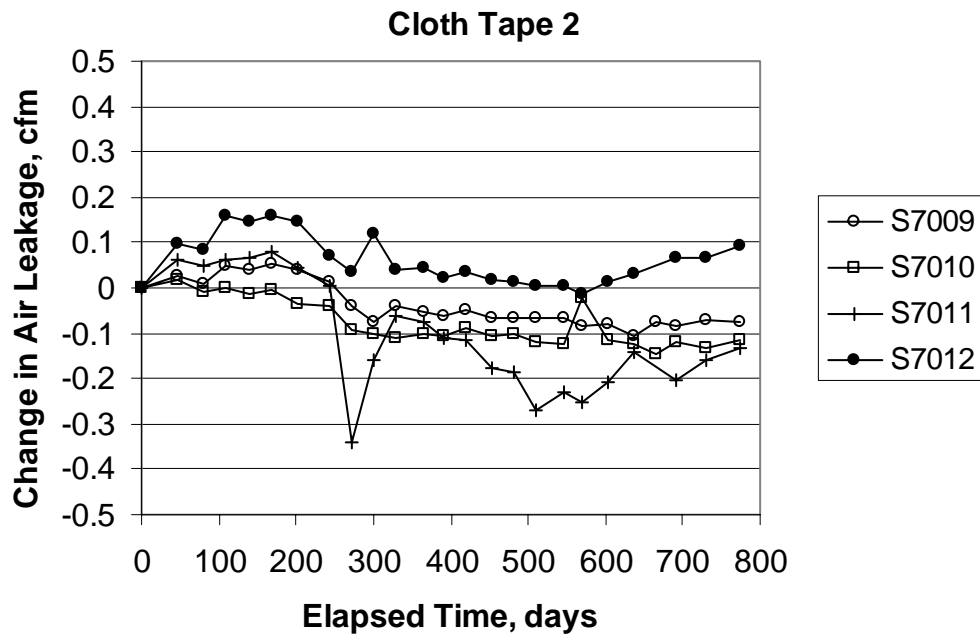
Figure 14 Two Year Testing Of Core-To-Collar Joint Specimens With Cloth Tape 2

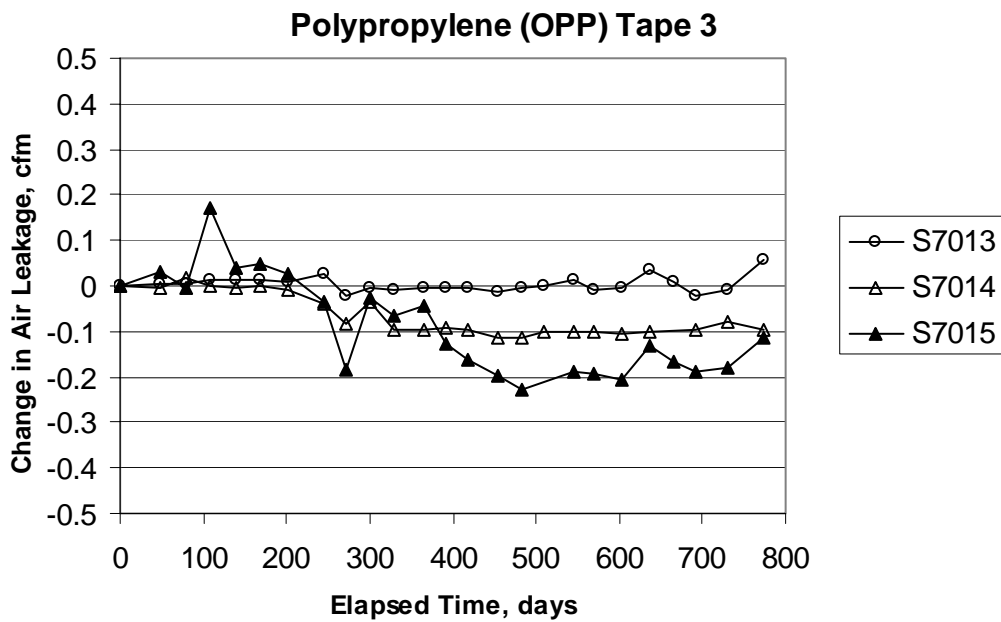
Figure 15 Two Year Testing Of Core-To-Collar Joint Specimens With Polypropylene Tape 3

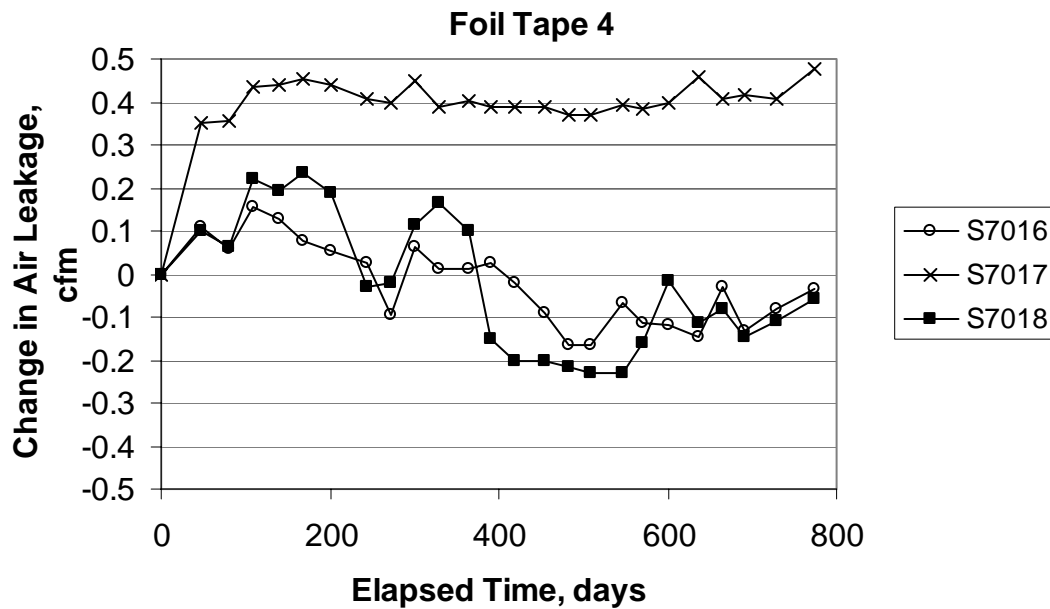
**Figure 16 Two Year Testing Of Core-To-Collar Joint Specimens With Foil Tape 4**

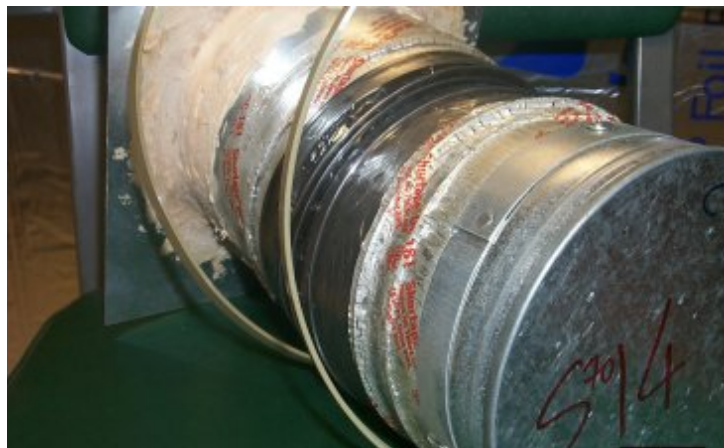
**Figure 17 Failed Plastic Strapping On One Of The Flexible Core To Sheet Metal Collar Specimens After Four Months Of Aging**

One sample (S7014) had strap failure after four months of aging (Figure 17). Other straps lasted longer, however, all but two failed by the end of testing. The two remaining straps show the same discoloration as failed straps – but have not completely fallen off. The results show no significant pattern for flange or end caps failing first, the two straps on each sample generally failed within a couple of months of each other. Strap failure potentially is a major problem because mechanical attachment thereafter only is maintained by the duct sealant. If ducts are not well-supported, significant mechanical stress can occur to cause the sealant to fail after the clamp fails.

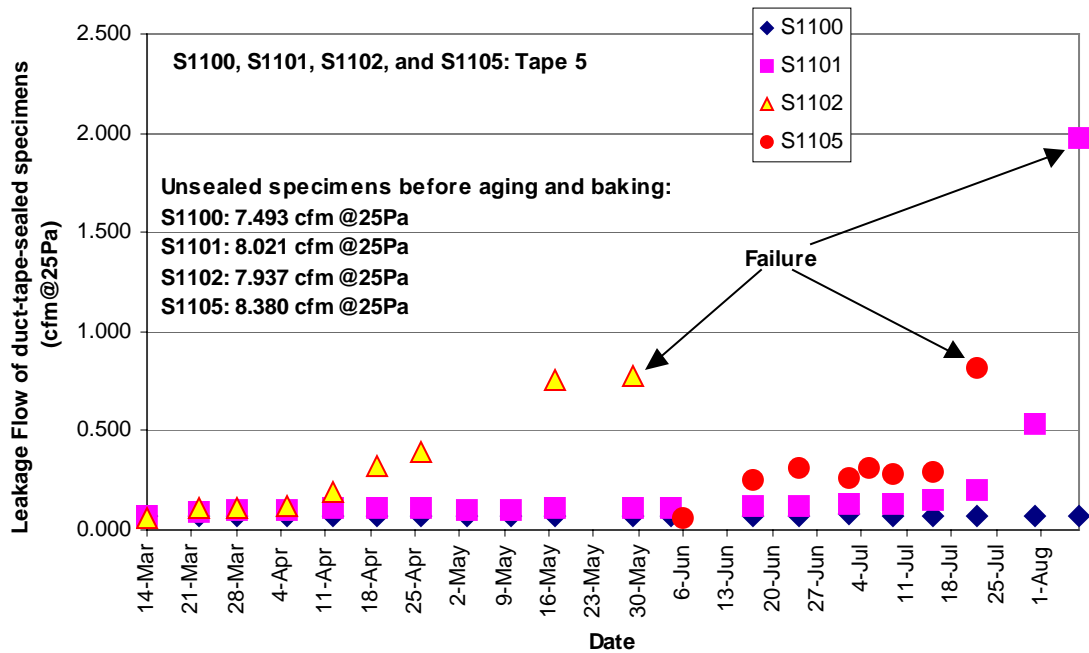
Figure 18 The Measured Leakage Of The Collar-To-Plenum Joint Tape-5 Specimens

Collar-to-plenum testing was performed for a new duct tape product that has been developed to have improved high temperature performance (Tape 5) as well a sample of Tape 1 as a control and for comparison purposes. The new tape was tested on the collar-to-plenum joint in order to facilitate performance comparisons with previously tested duct sealant products. The old tape (Tape 1) failed in 9 days, showing shrinkage and pulling away from the sheet metal plenum. The new tape showed substantially better durability performance failing after about 60 days. Additional tests at lower temperatures showed that the new tape takes longer to fail as temperatures are decreased, and at temperatures below (111°F) 44°C the tape takes more than 100 days to fail (we limited our test duration to 100 days). Figure 18 and Figure 19 show more detailed test results. Because they were mounted in a different location on the test apparatus, these collar-to-plenum samples were exposed to different temperatures than the core to collar samples. Table 6 shows the temperatures the specimens were exposed to during the test, and the corresponding elapsed time before failure.

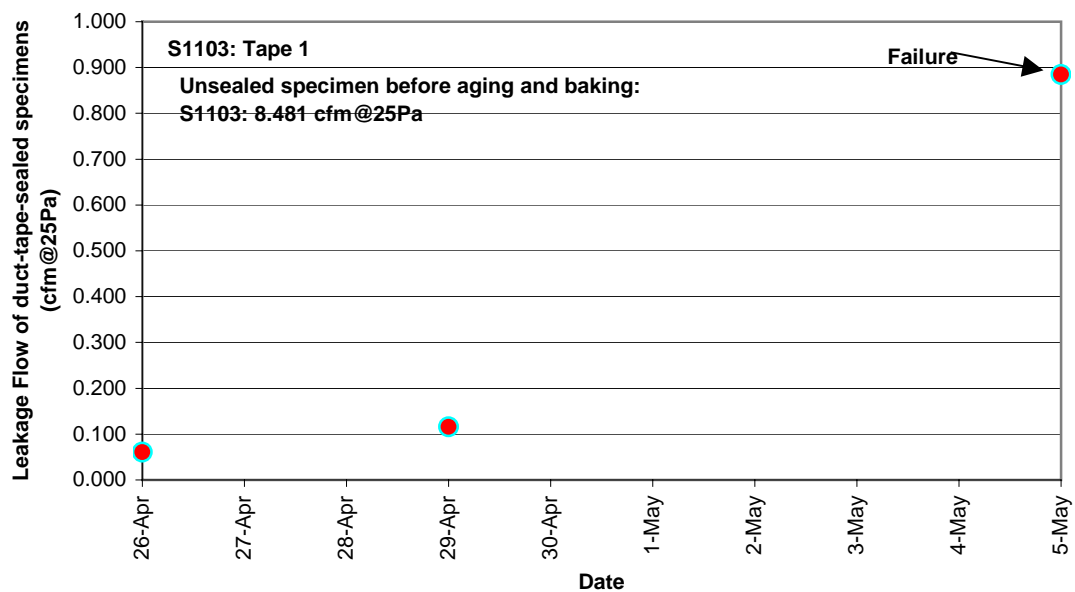
Figure 19 Leakage Of The Collar-To-Plenum Joint Tape-1 Specimen

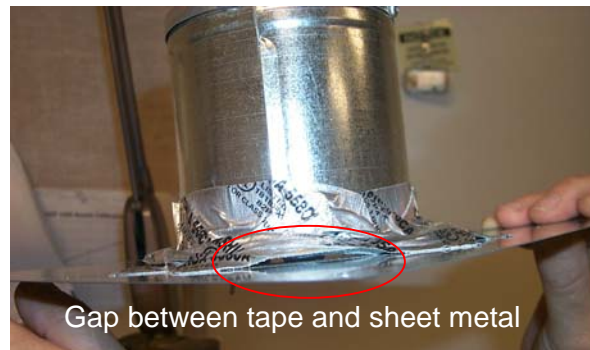
**Figure 20 Example Failure Of The Collar-To-Plenum Joint For Tape 5**

Figure 20 shows the failure of the joint as the duct tape tends to pull away from the sheet metal, thus uncovering the series of overlapping fin-joints.

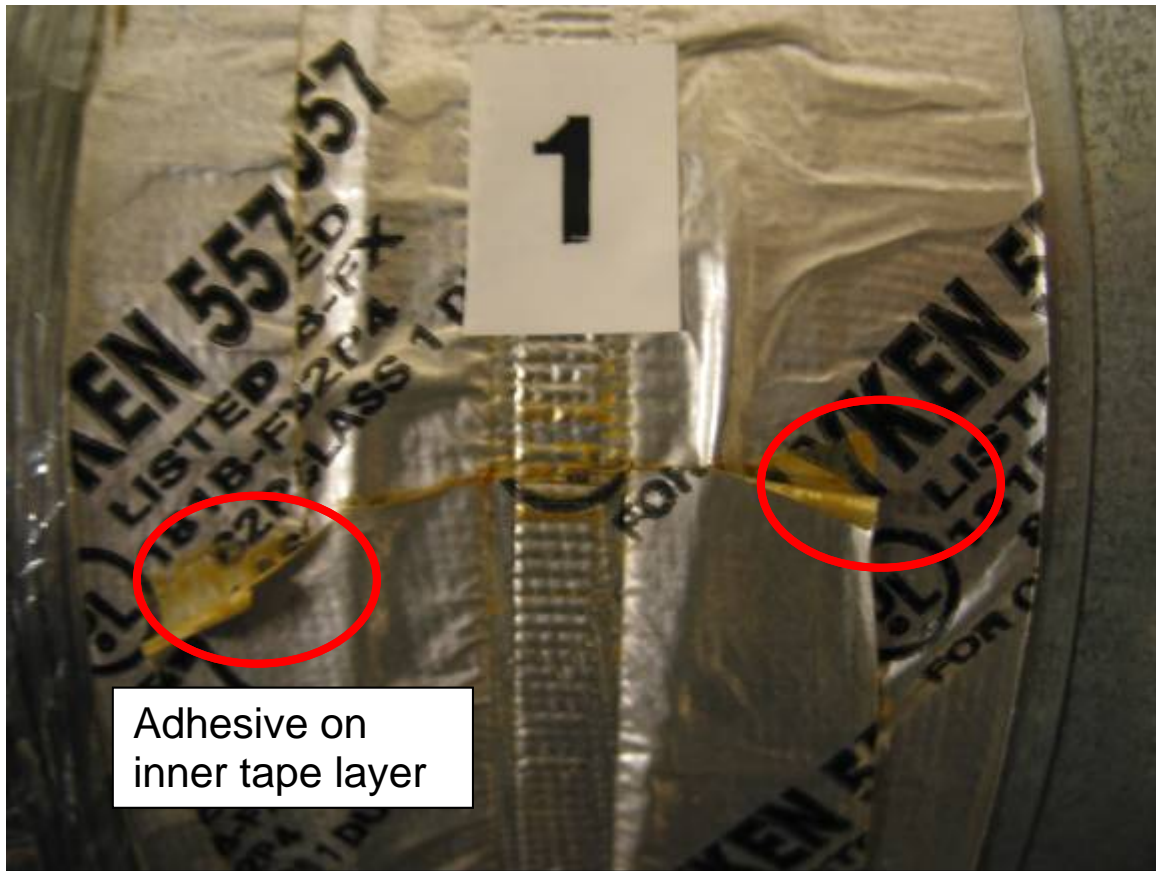
Figure A1. Sample 1. This figure shows the curling of the tape end where it is no longer stuck to the inner layer of tape. The yellow (circled) areas show where the adhesive has remained on the inner tape layer. The tape edges have curled away from the duct and the tape surface is wrinkled. The indentations in the center of the tape shows where the strap used to be before it fell off.

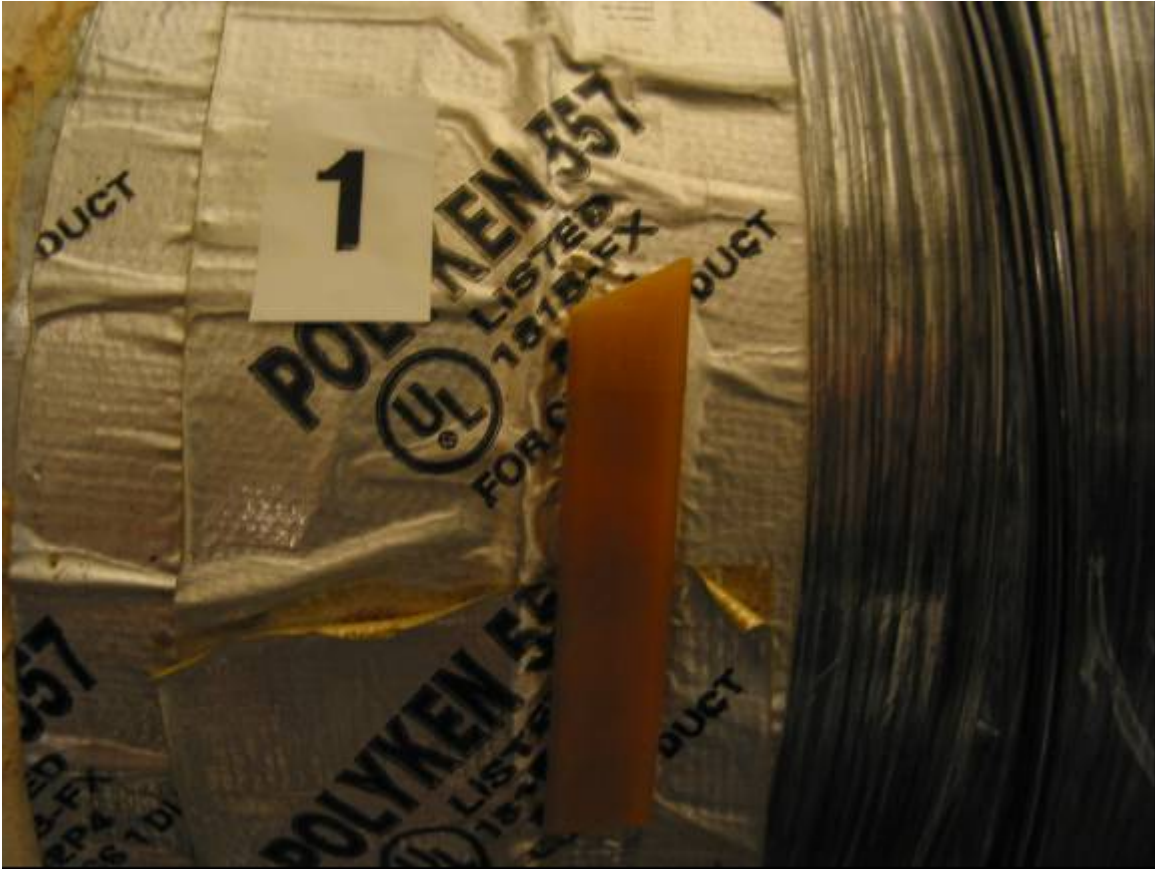
Figure A2. Sample 1. The second seal still has part of the nylon clamp in place. This shows the same characteristics as in Figure A1.

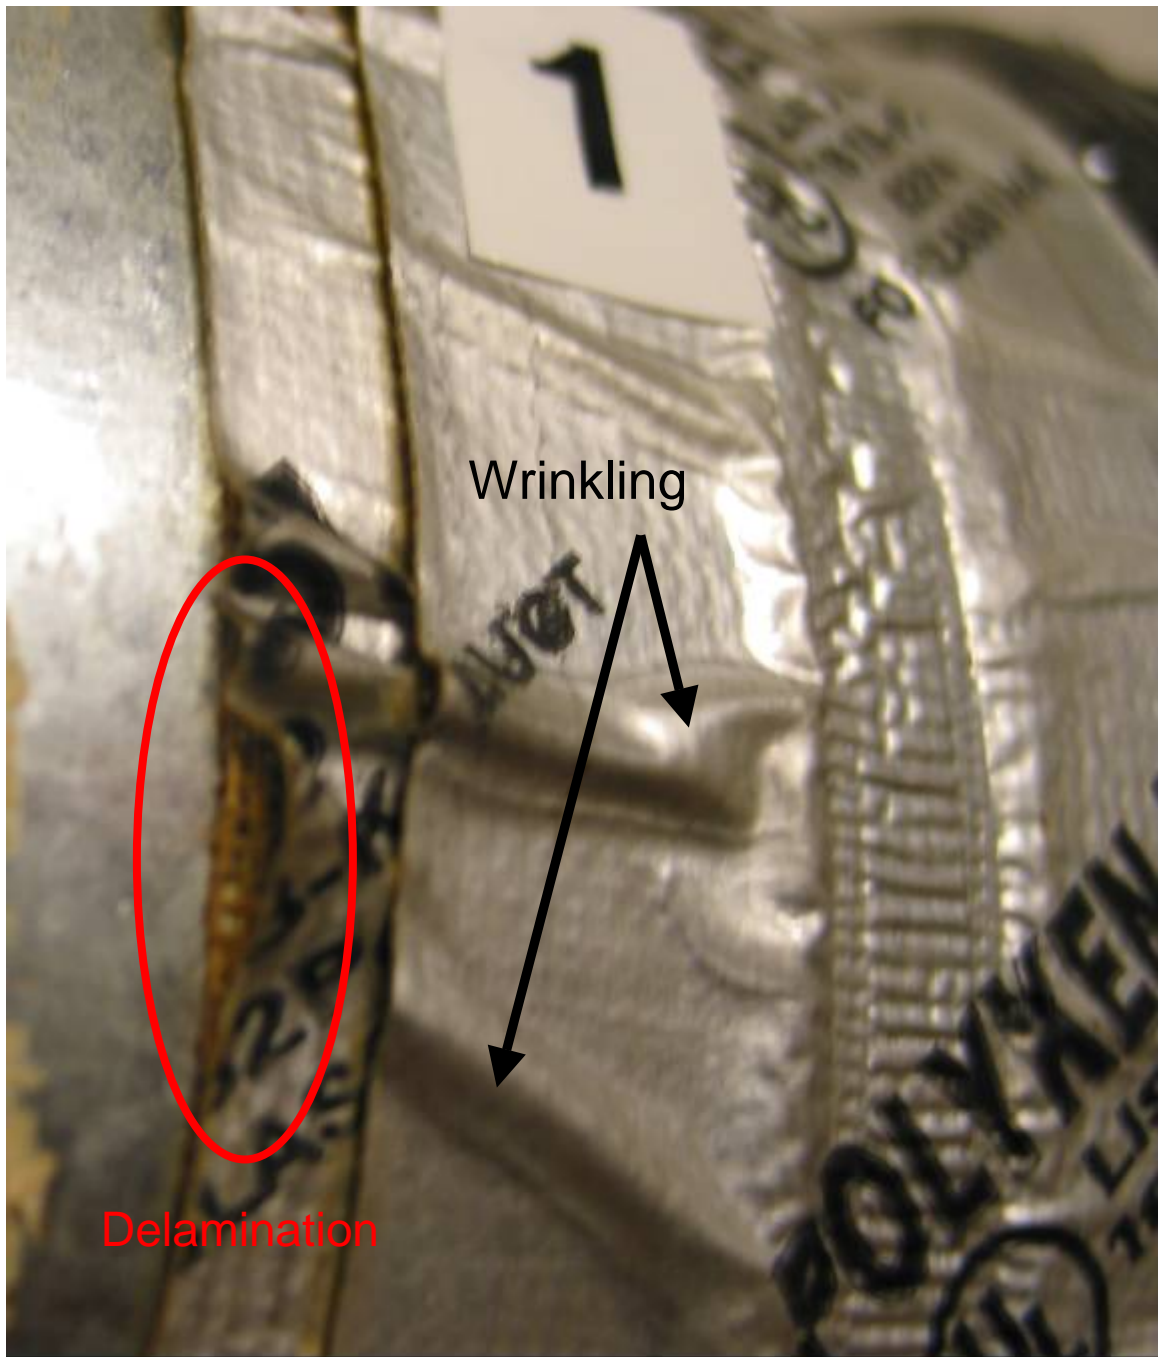
Figure A3. Sample 1. The tape shows wrinkling and delamination of the reinforcing mesh from the tape backing.

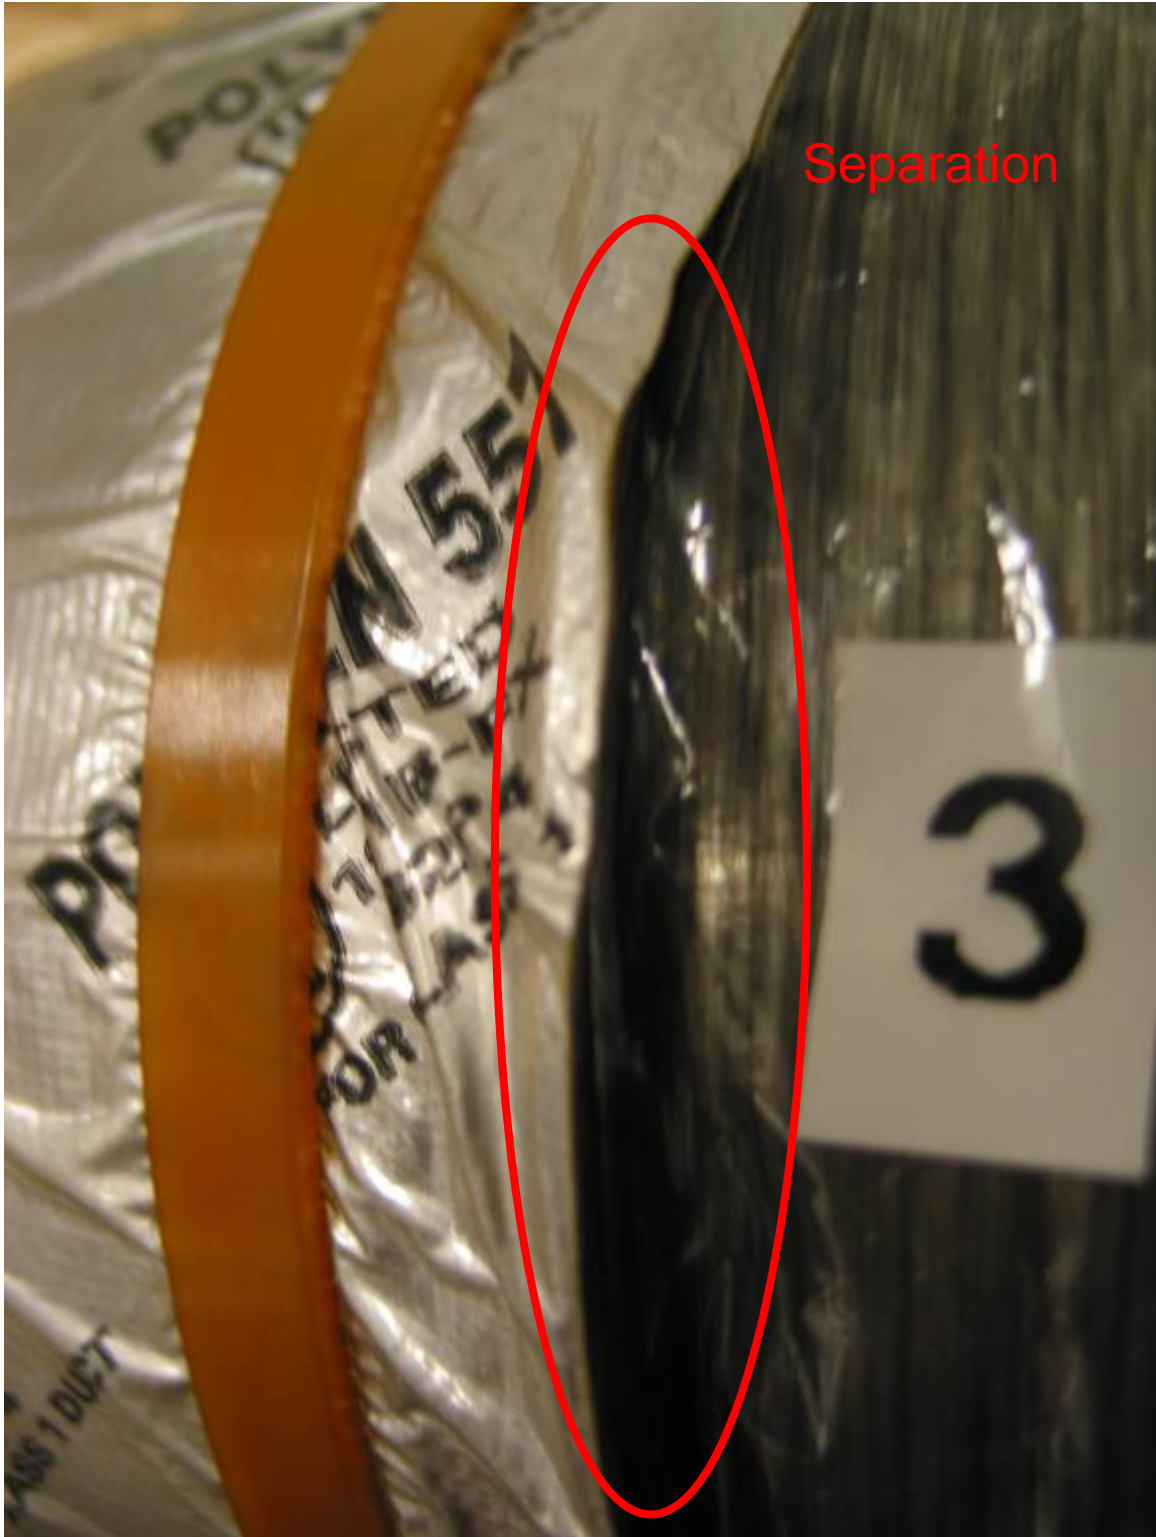
Figure A4. Sample 3. Tape has separated from the flex duct core at the tape edges

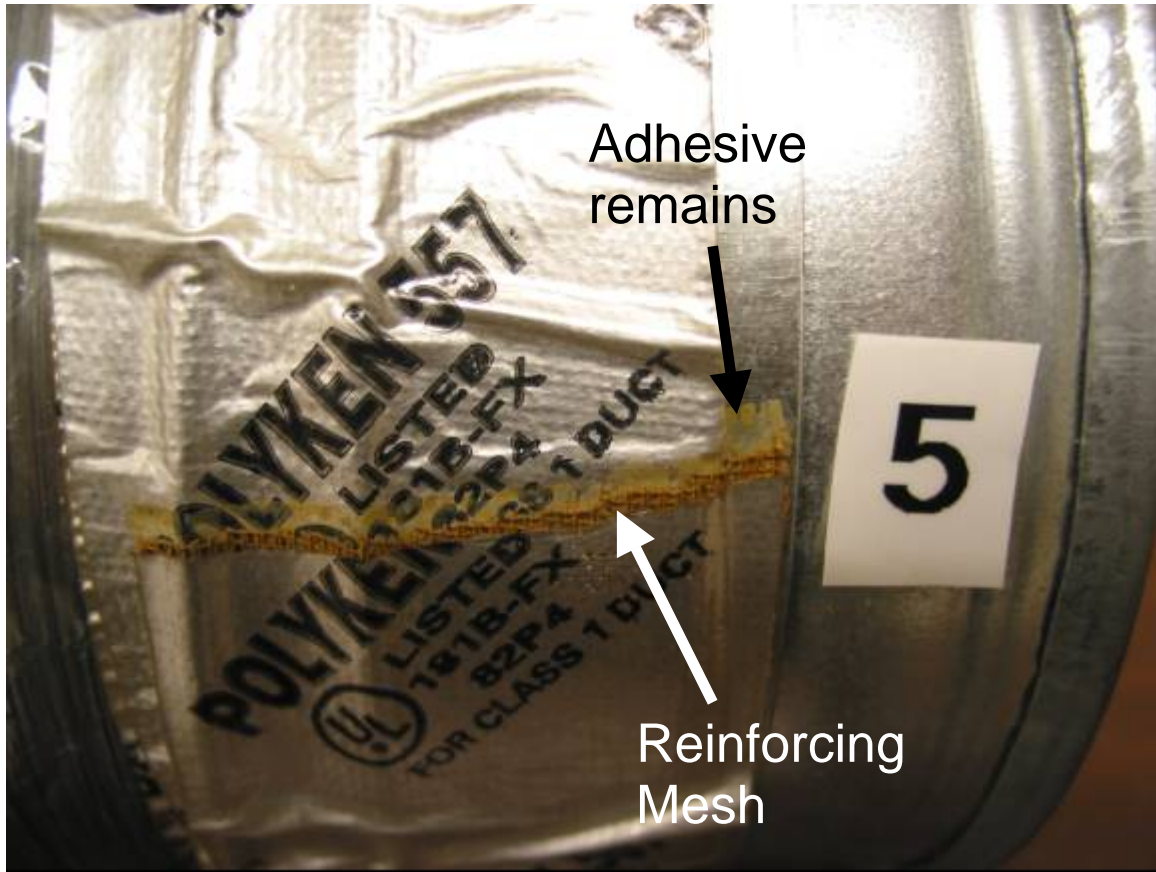
Figure A5. Sample 5. The end of the tape shows shrinkage and delamination. Compare this to Figure A1, where the presence of the clamp in A1 reduces the shrinkage and delamination at the center of the tape. This figure clearly shows the adhesive left where the tape was originally attached and the reinforcing mesh separated from the backing.

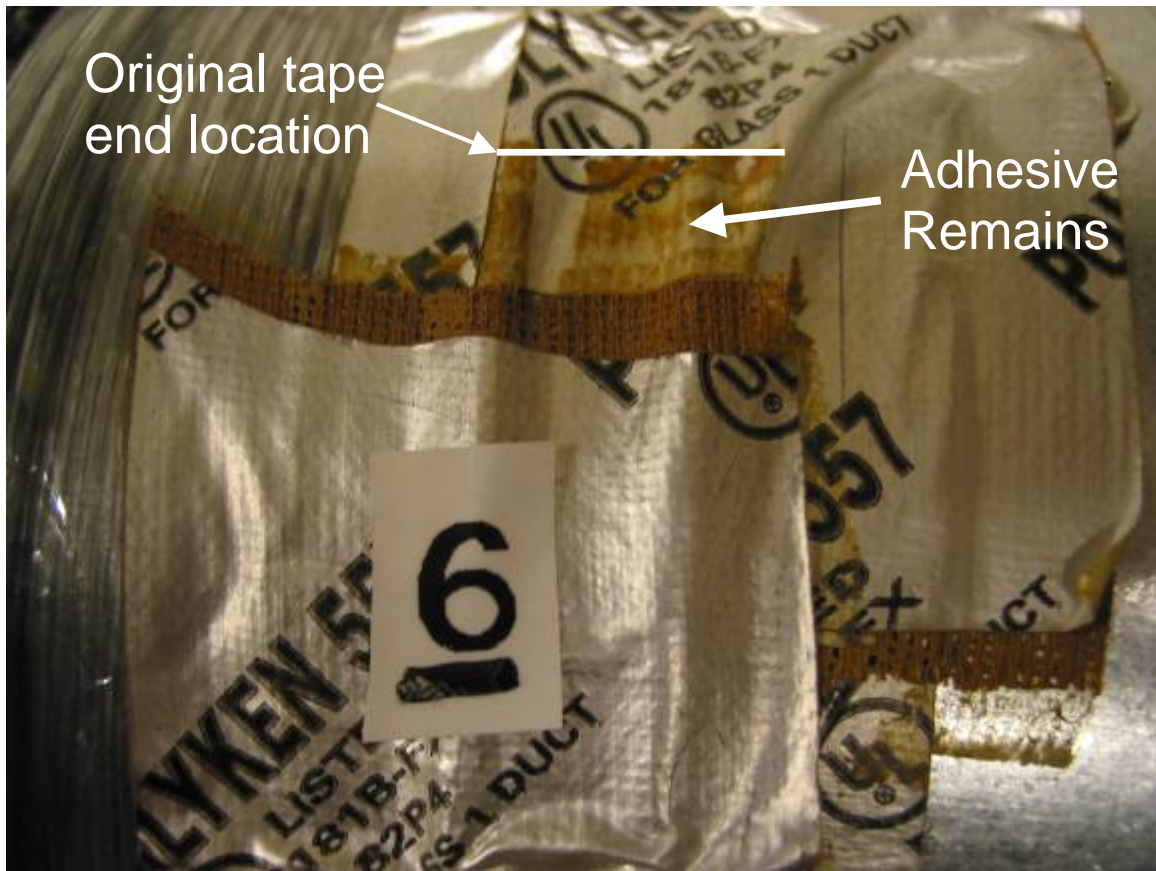
Figure A6. Sample 6. This figure is similar to Figure A5, but shows even more shrinkage.

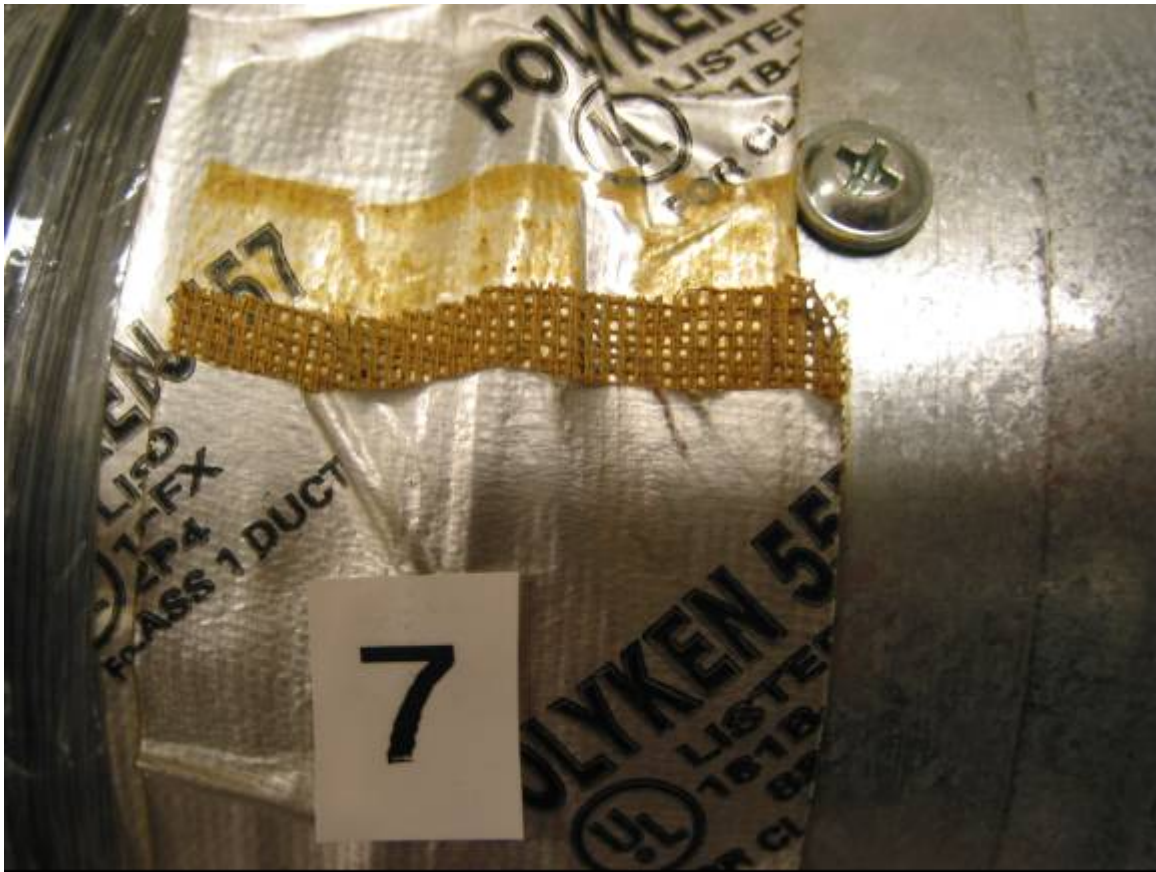
Figure A7. Sample 7. Like sample 6, sample 7 shows considerable shrinkage and delamination.

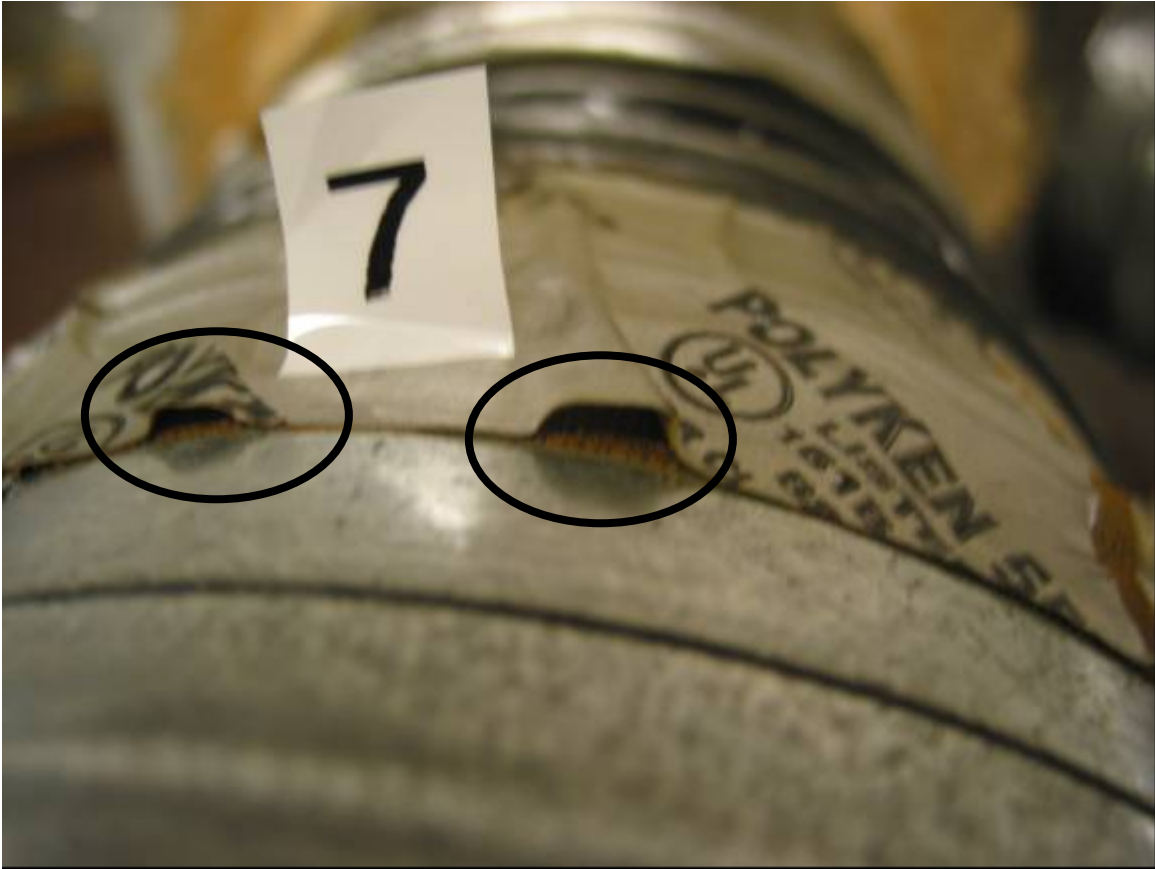
Figure A8. Sample 7. The edges of the tape have lifted off the duct surface in large wrinkles.

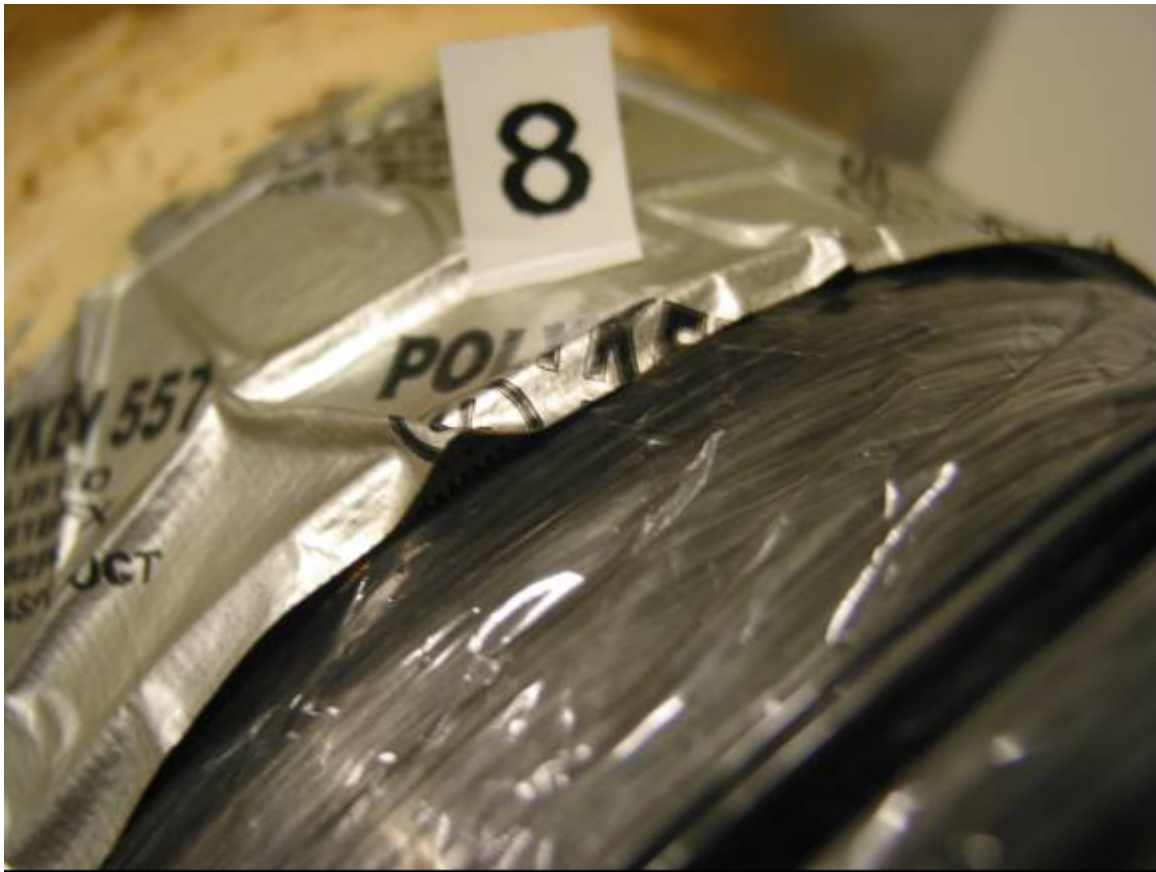
Figure A9. Sample 8. The edges of the tape are no longer stuck to the flex duct core.

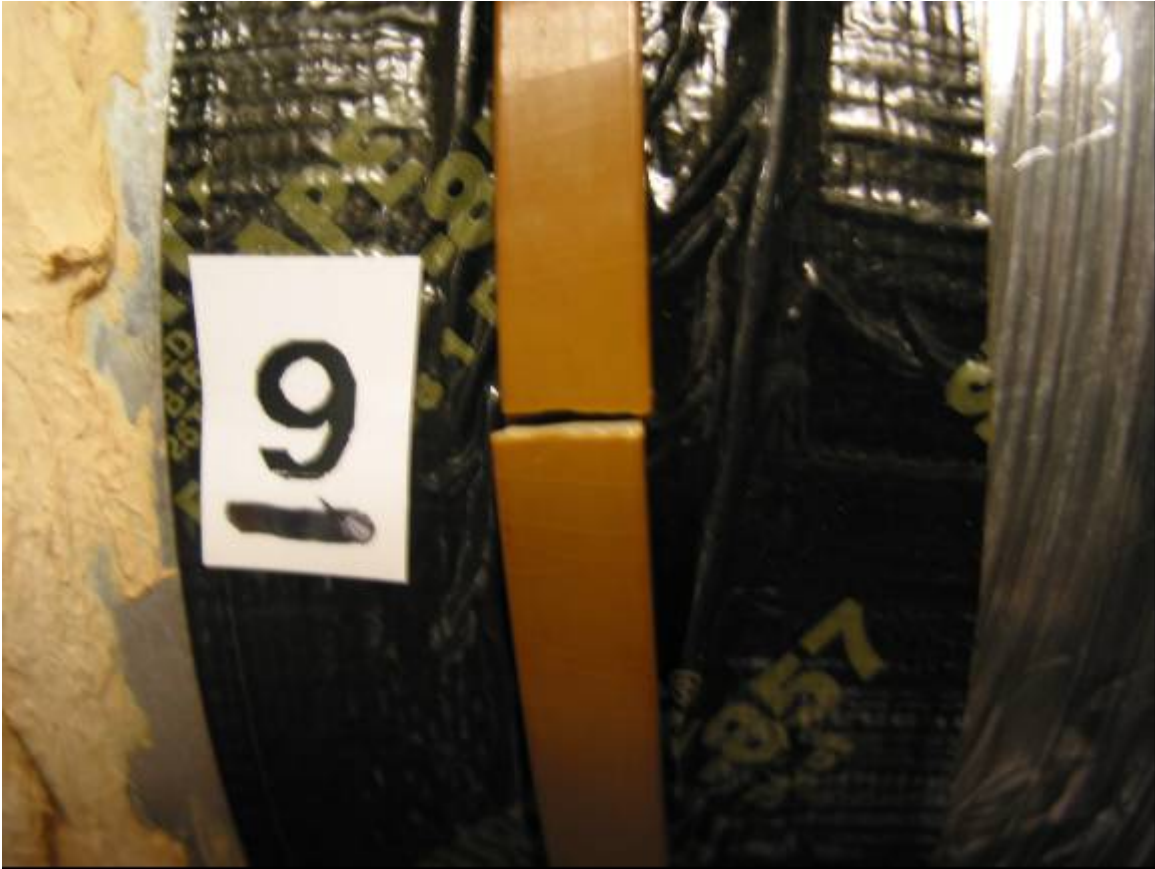
**Figure A10. Sample 9. The clamp shows its brittle failure. Note that these clamp sections are now held in place because they are stuck to the duct tape.**
