# Duct Tape Durability Testing

**California Energy Commission**  
Public Interest Energy Research Program

**Lawrence Berkeley National  
Laboratory**

JANUARY 2005  
CEC-500-2005-008

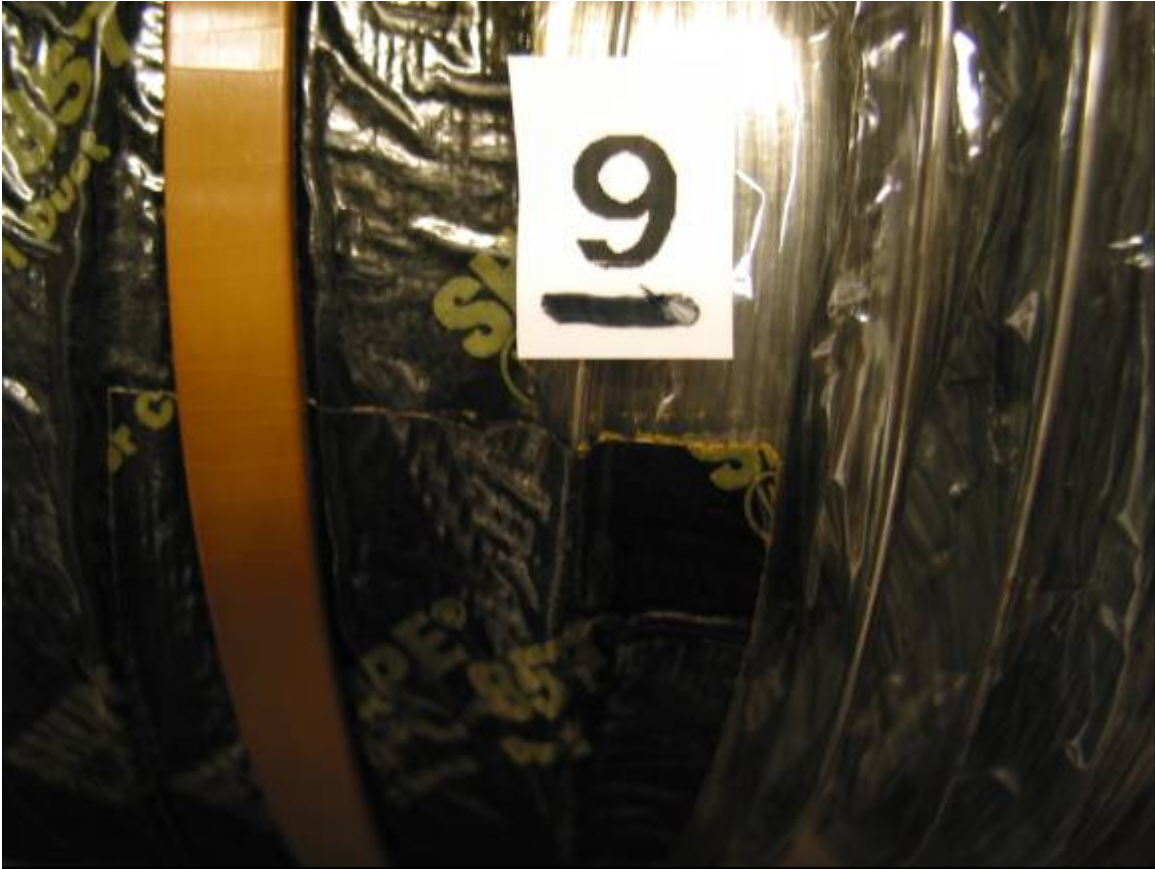
Figure A11. Sample 9. This sample shows almost no shrinkage or delamination.

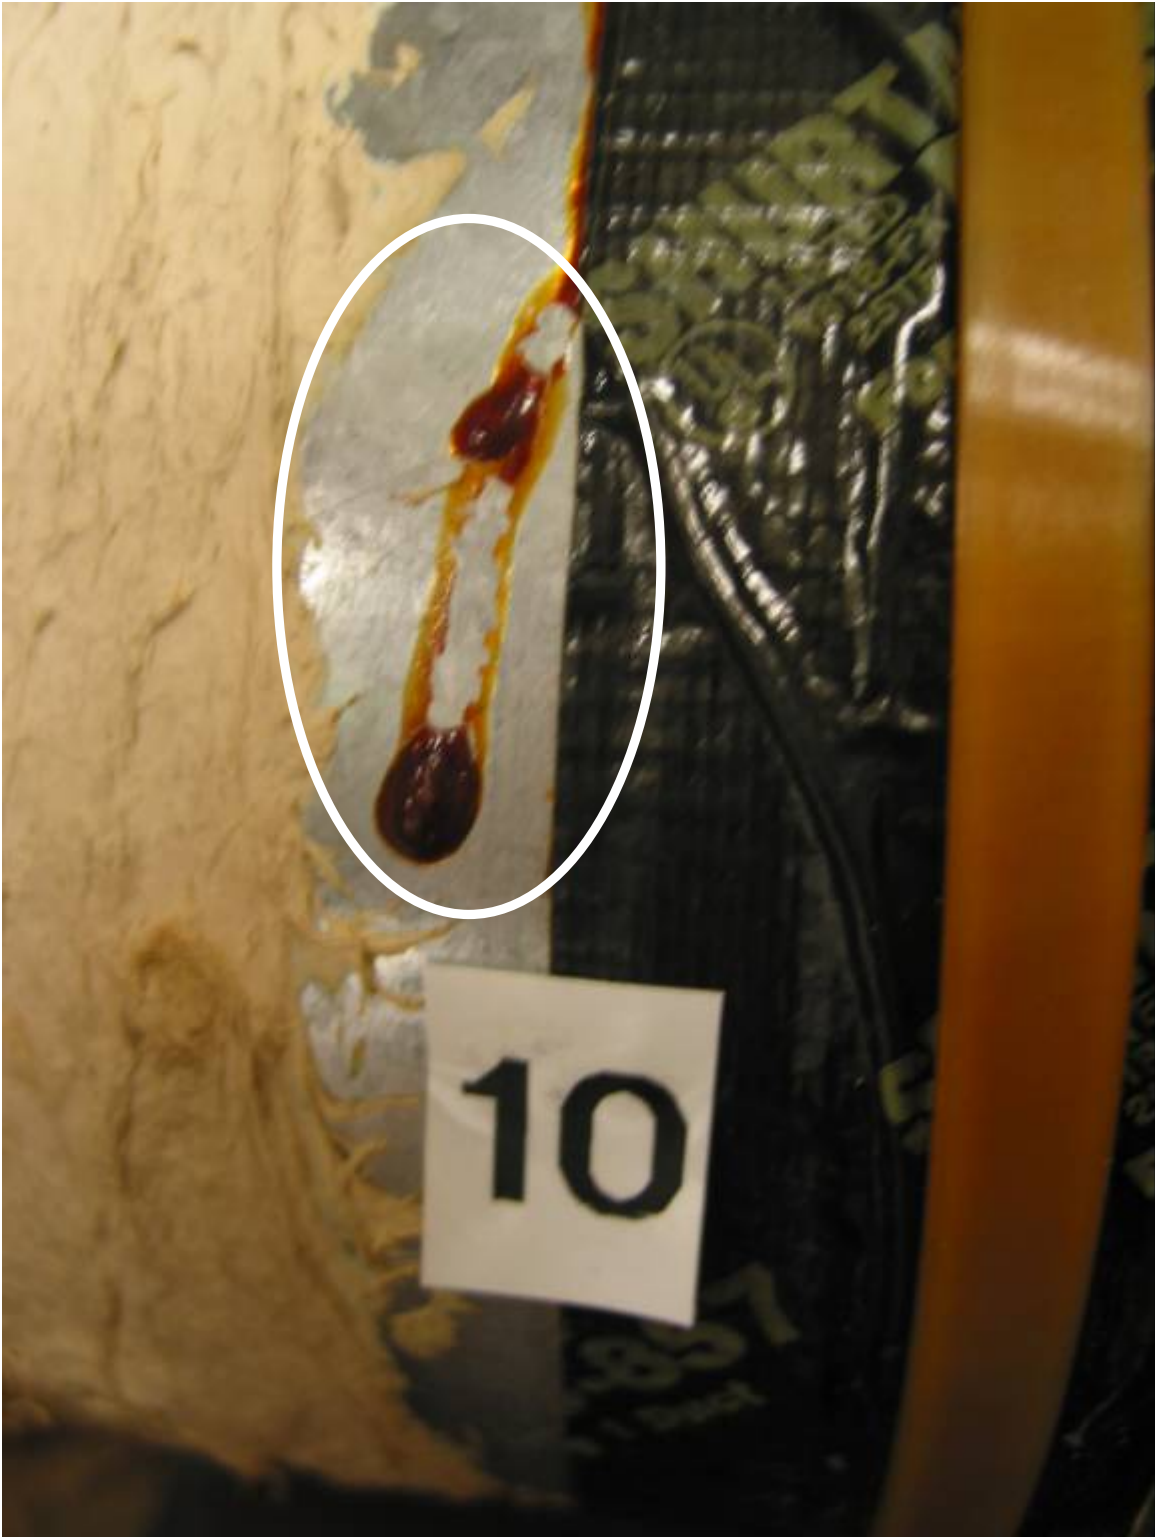
**Figure A12. Sample 10. The adhesive has oozed out onto the surface of the duct.**

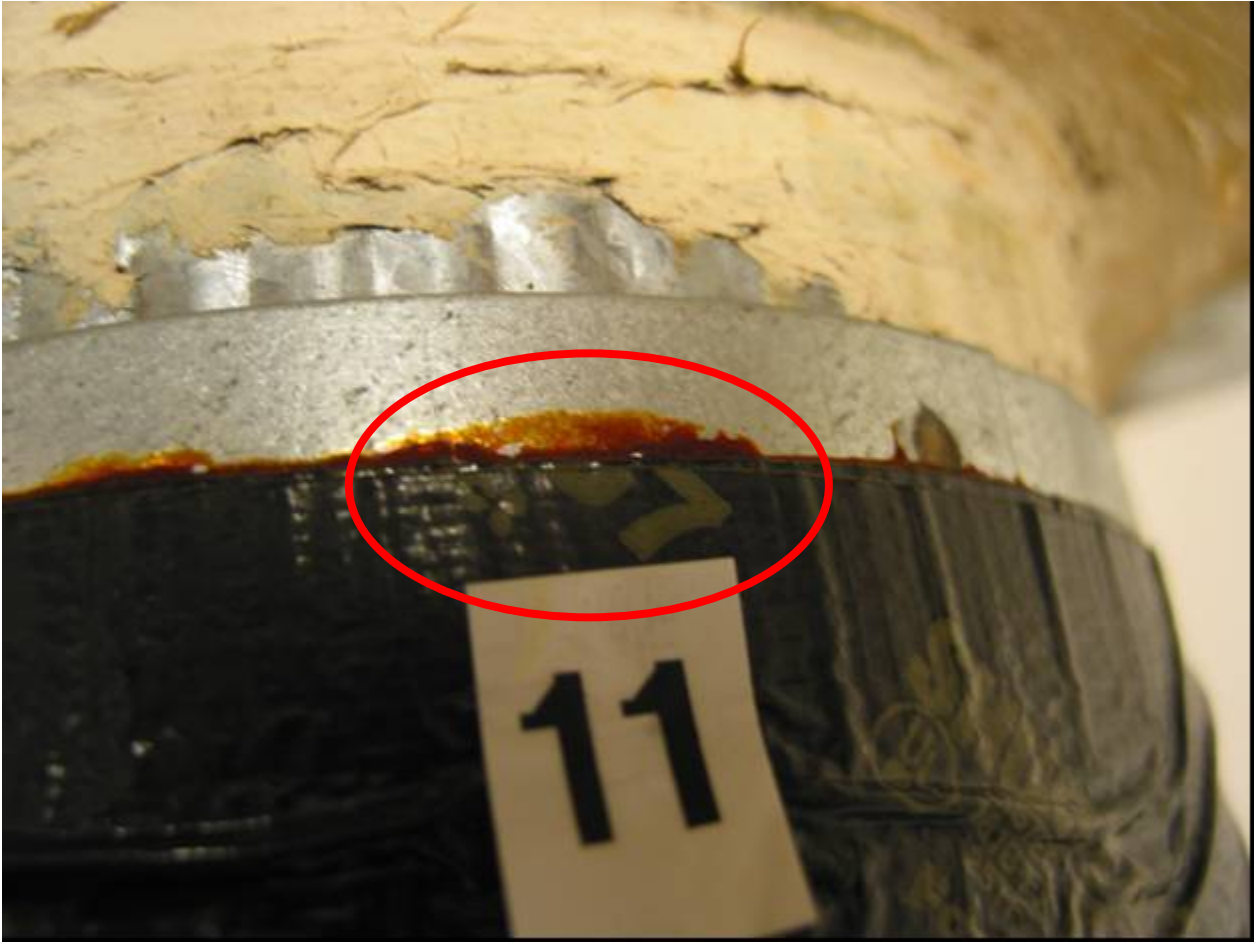
Figure A13. Sample 11. The adhesive has oozed out the edge of the tape.

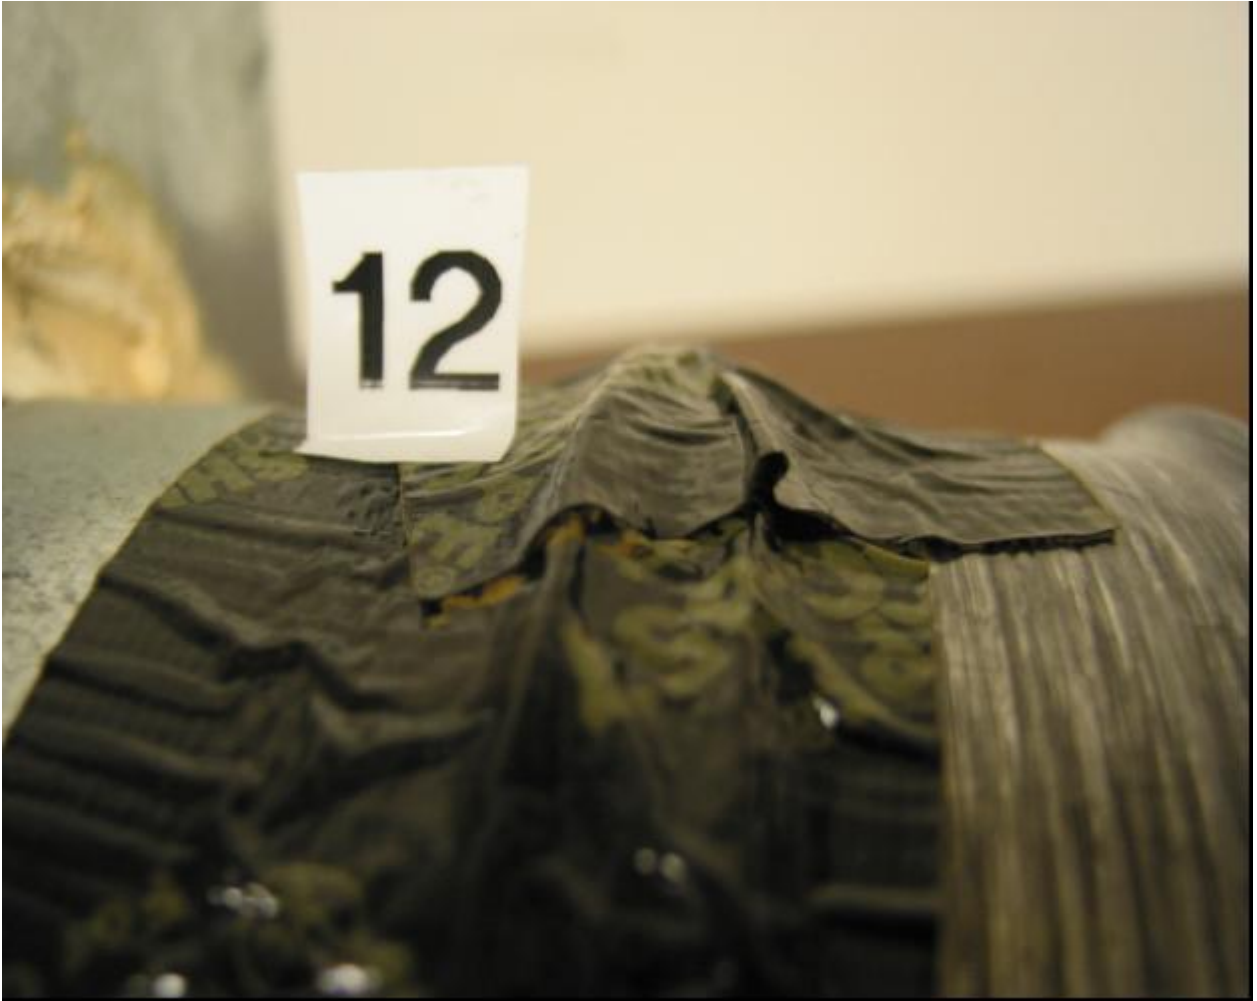
Figure A14. Sample 12. The end of the tape has wrinkled and shrunk.

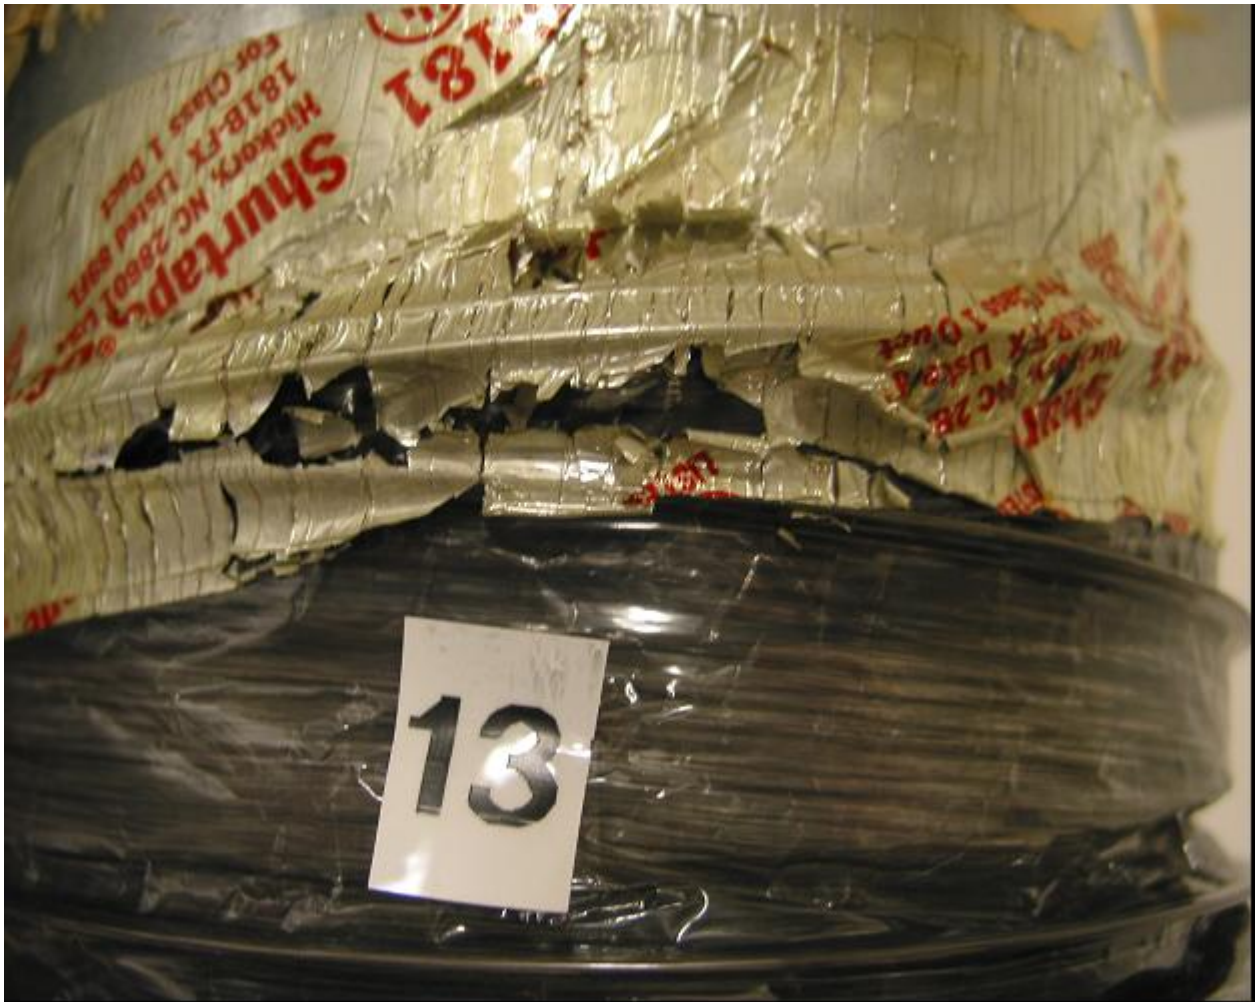
Figure A15. Sample 13. This sample shows cracking and disintegration of the tape

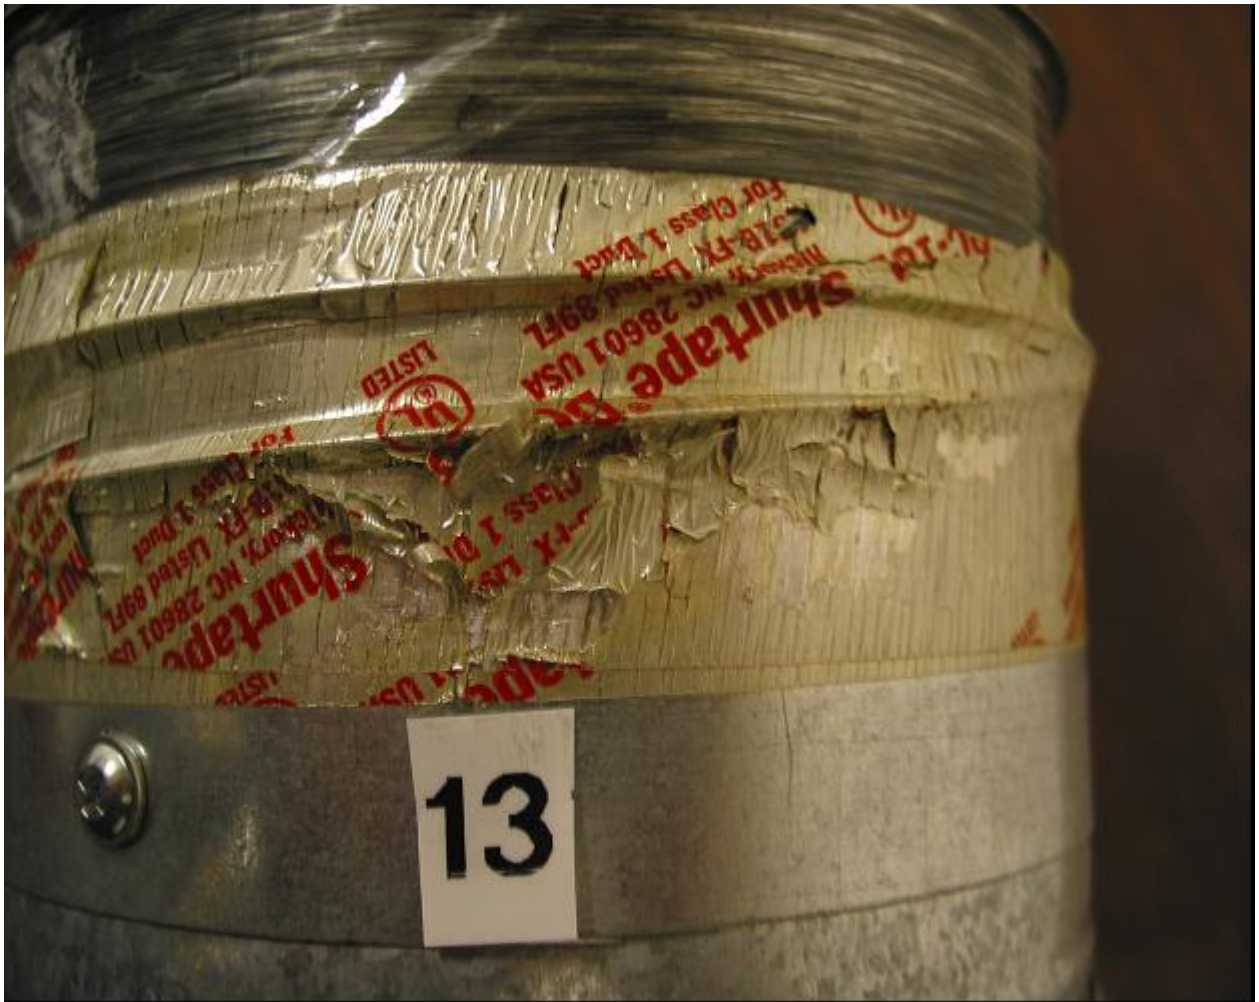
Figure A16. Sample 13. This sample is cracking and peeling.

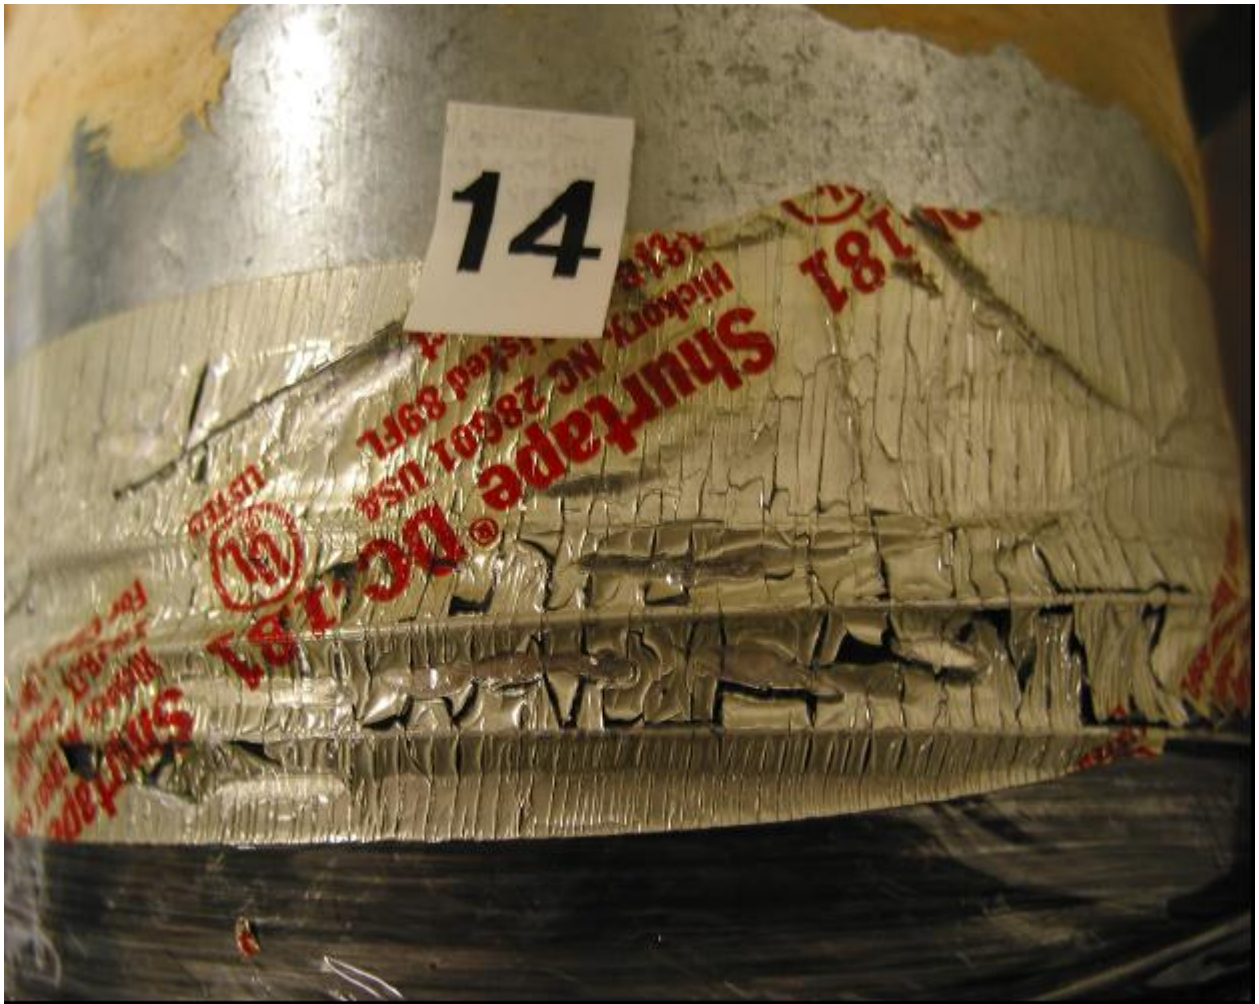
Figure A17. Sample 14. This sample shows the same cracking and splitting as Sample 13.

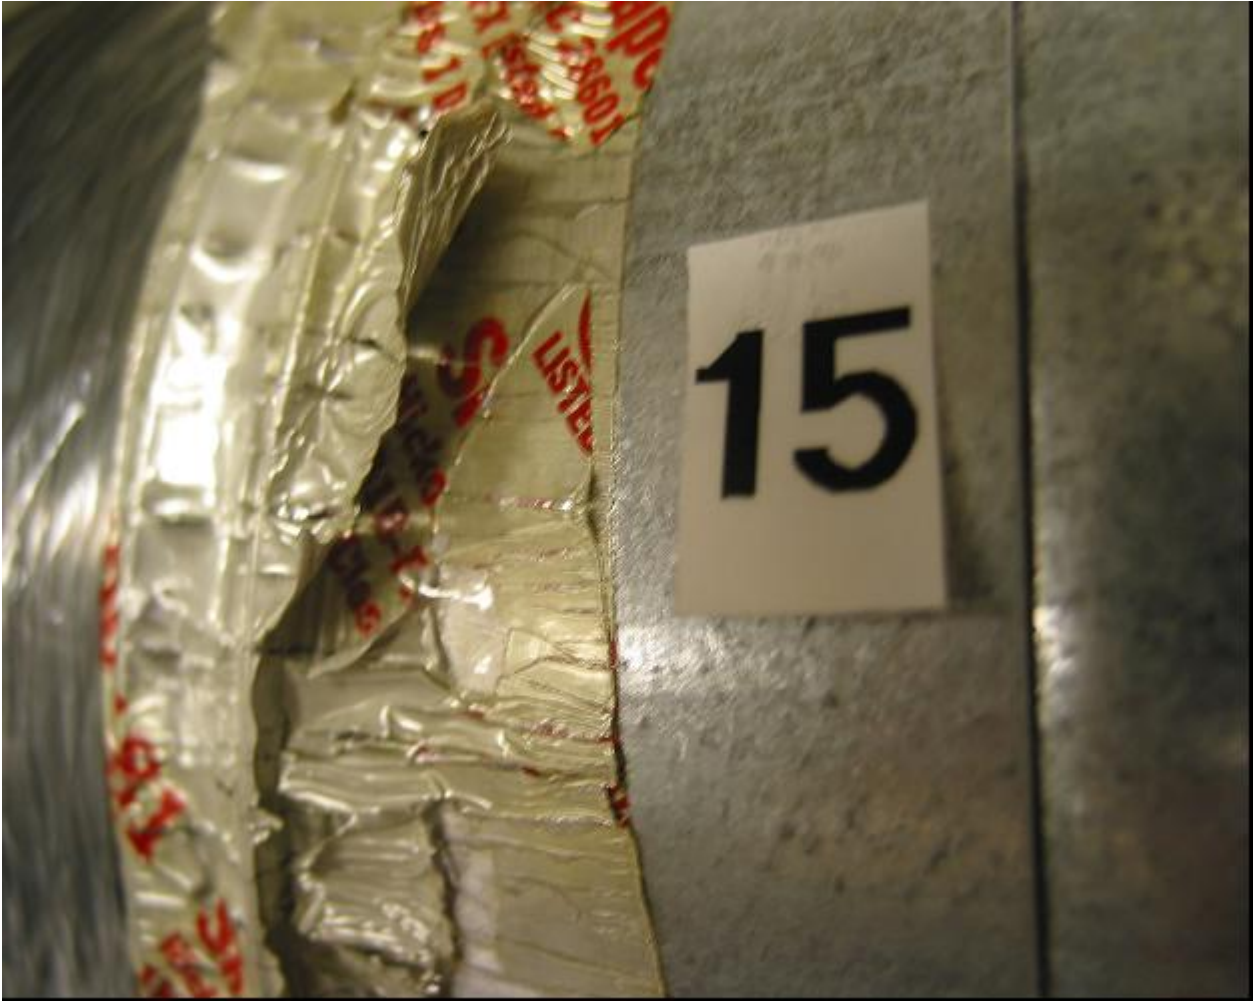
Figure A18. Sample 15. Like samples 13 and 14, this sample is also peeling and cracking. This figure shows how the metallized layer is splitting from the adhesive layer.

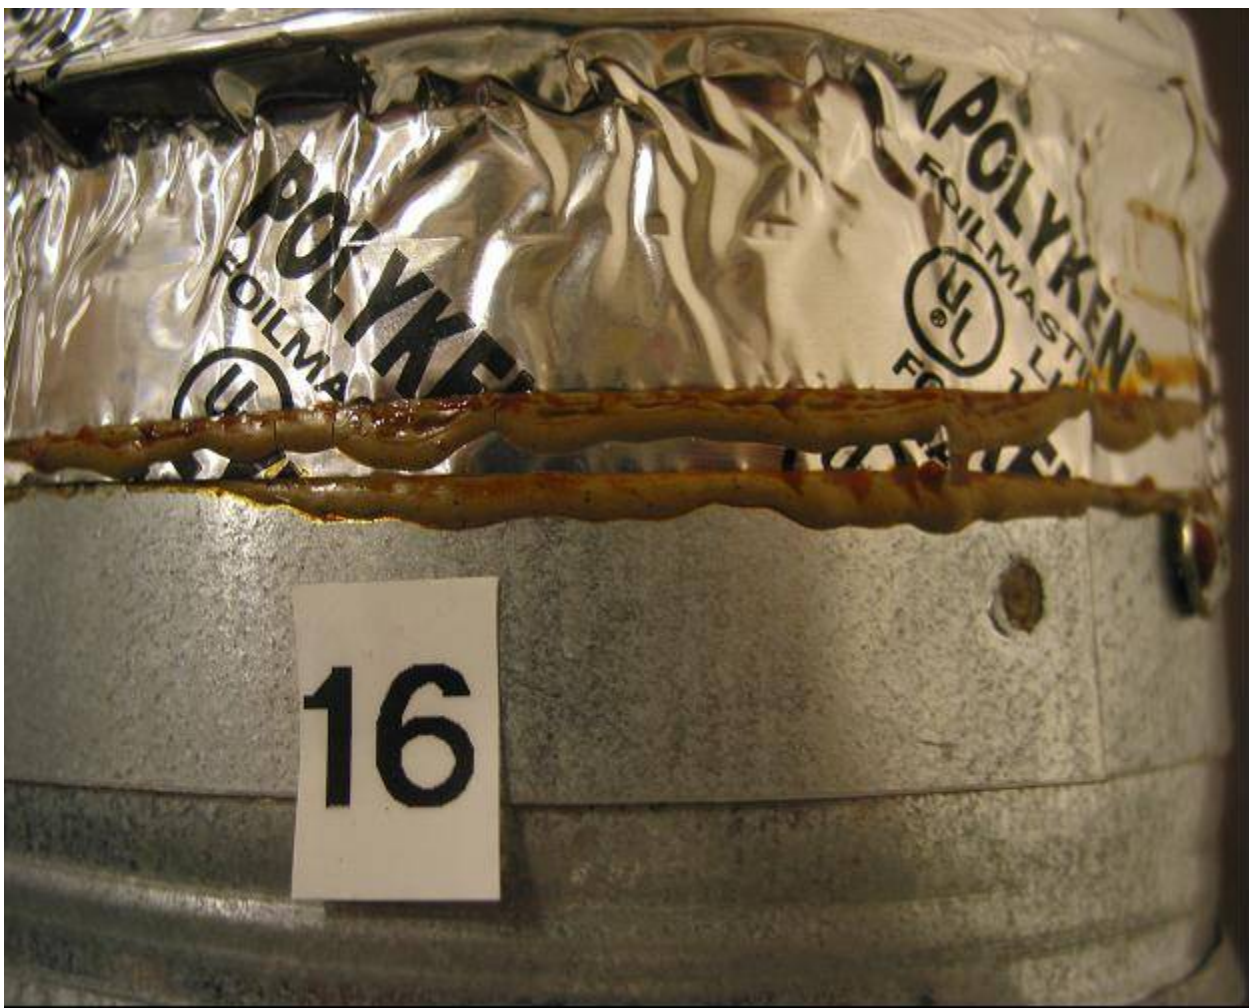
Figure A19. Sample 16. This sample shows oozing of the adhesive at the tape edges.

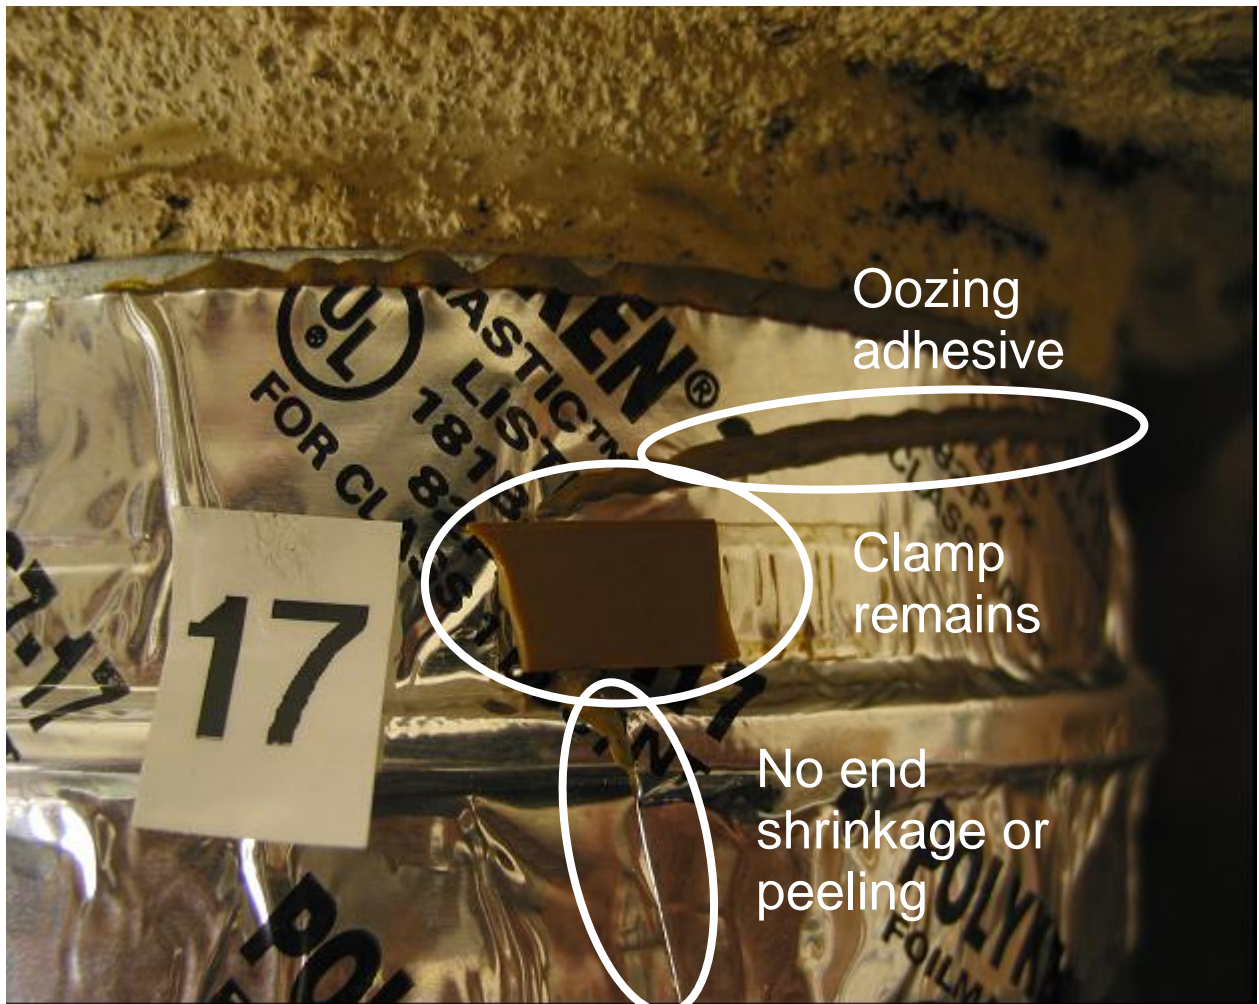
Figure A20. Sample 17. As with sample 16, this metal foil tape is showing oozing of the adhesive. Note that there is no shrinkage or delamination like the other tapes at the end of the tape. There is also a small piece of clamp stuck in place by the oozed adhesive.
